## **Appendix B**

### **Tributary to Rocky Branch (244) Subwatershed Project Conceptual Design Narratives**

## Project: Tributary to Rocky Branch 244-688 Water Quality Retrofit

## Project: Tributary to Rocky Branch 244-689 Major Repair

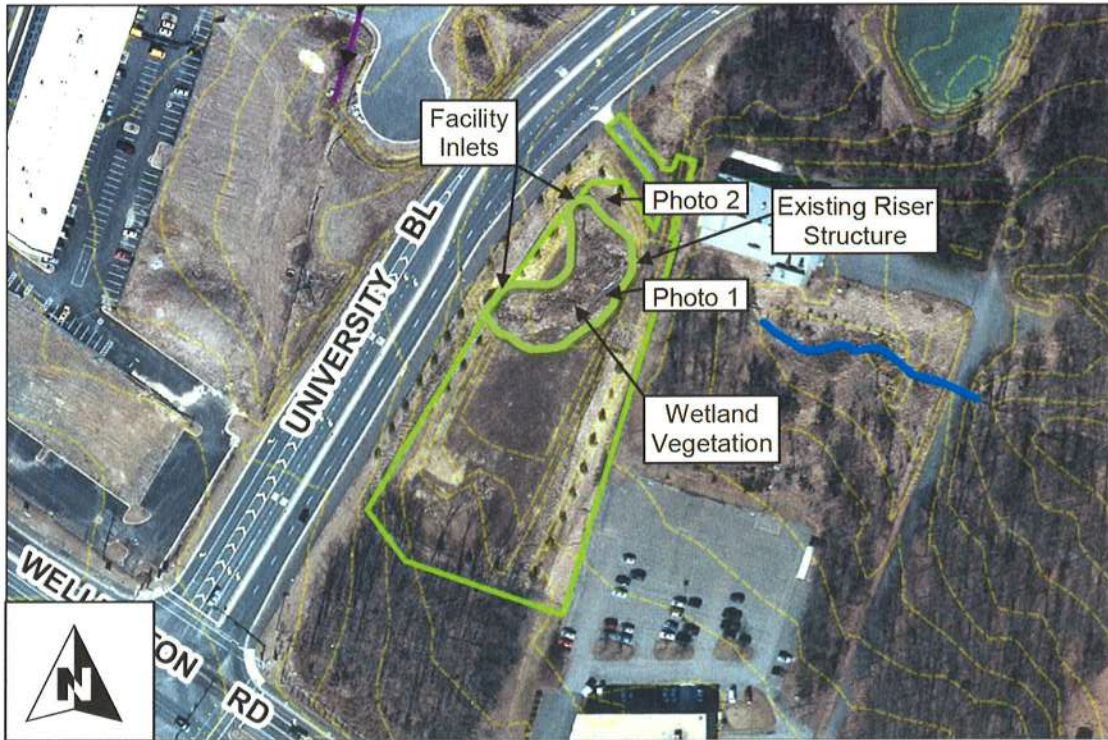
**Problem Description:** The facility was recorded in the County database in 2010 as a dry basin with an 84 inch riser. About 1/3<sup>rd</sup> of the facility is a wetland due to the low flow orifice being clogged. The existing facility lacks sediment forebays which allows sediment and other debris to settle out at the riser. The two inlets have fairly short flow paths to the riser (<0.4 path/length). The facility is fairly large (37,600 SF) which represents about 2.7% of the contributing drainage area. The far end appears to receive minimal ponding and is mowed grass.

**Existing Condition:** Facility designed as a dry pond is supporting wetland vegetation due to clogged low flow orifice. Flow has a short path to outlet structure.

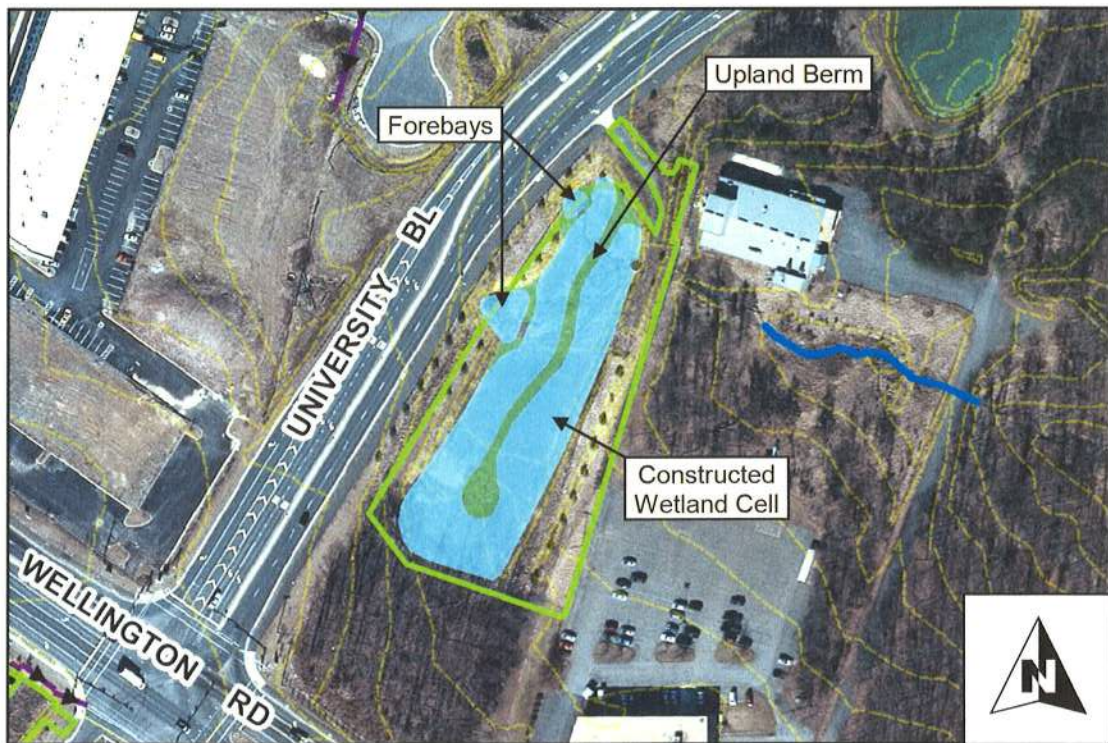
**Conceptual Plan:** Conversion to a wetland will increase N and P removal. Facility includes forebays for pretreatment and a berm to increase flow path.

**Project Description:** This facility could be retrofitted with a constructed wetland including two sediment forebays, a micropool and a berm. The berm would increase the flow path by 4x, preventing short cutting and increasing treatment, and meet the Level II design standard. The length width ratio exceeds 3:1, which meets the Level II design standard. The basin size to drainage area ratio of 2.7% meets the Level I design standards. The forebays would capture sediment, and improve performance. The micropool would improve the function of the riser. The conceptual design meets Level I design standards, but may provide higher N and P removal due to a longer flow path.

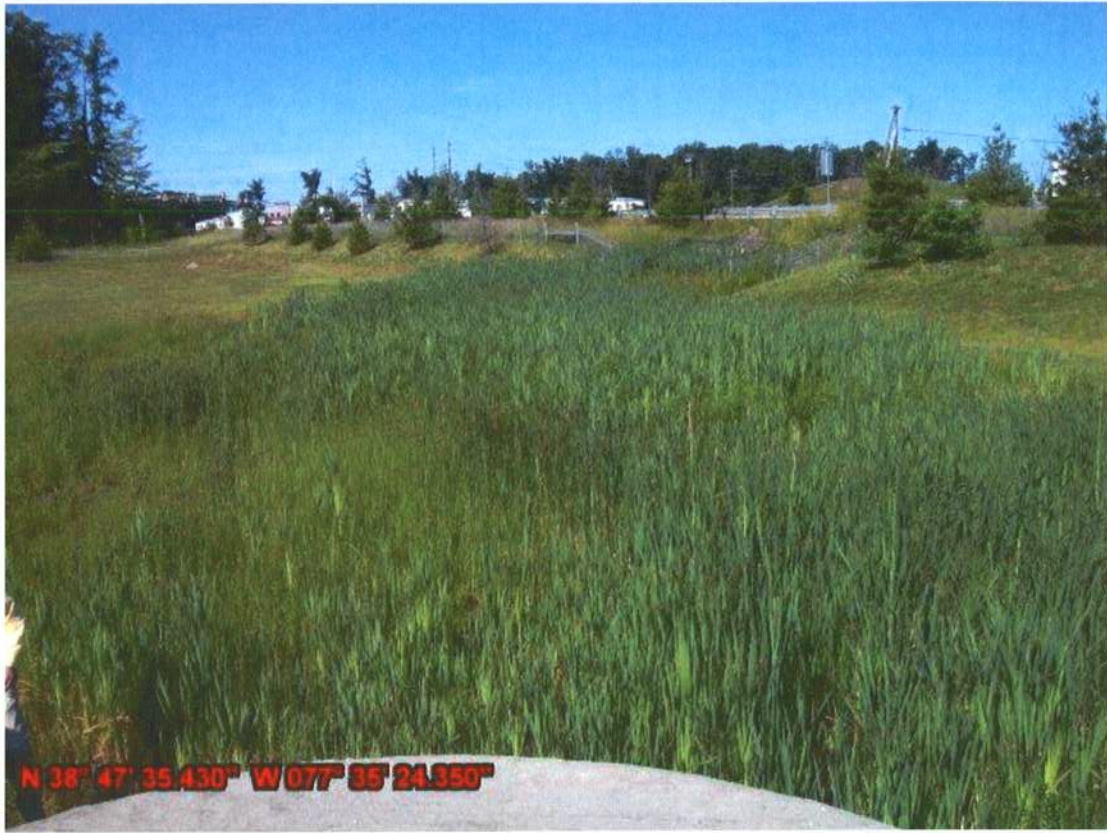
**Photo 1:** Large dry basin supporting wetland vegetation over about 33% of the basin

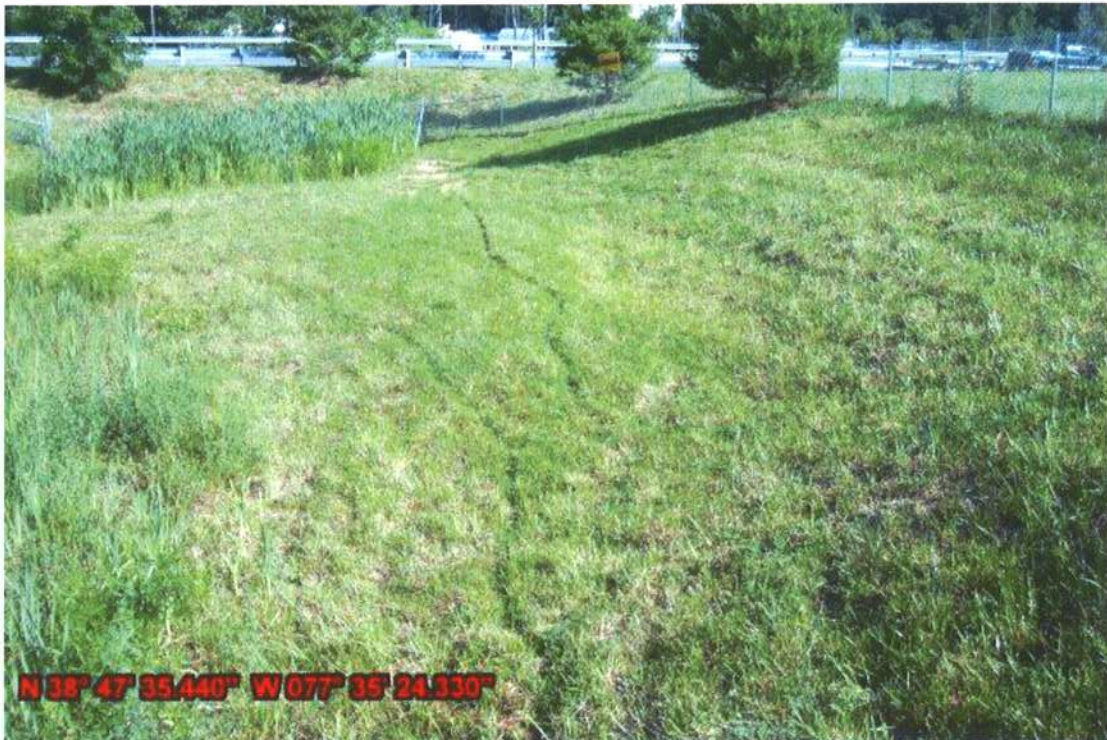
**Photo 2:** Significant portion of basin is currently not wetland

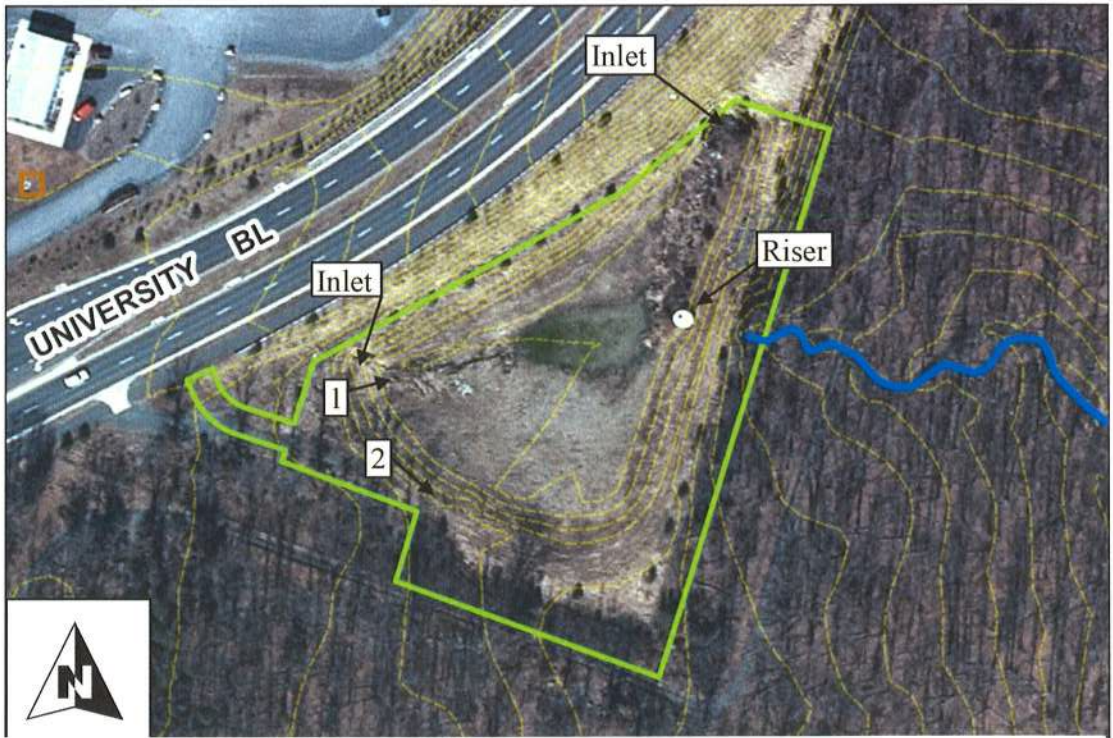
**Problem Description:** This facility is listed in the database as a dry basin BMP and was added to the inventory in 2010. However, the facility is visible on 2006 aerial photography. The riser appears to be designed for a wet pond instead of a dry pond as reported in the database. A 4-inch low flow orifice is reported in the database but was not observed in the field. During site inspection the facility was ponded and heavily loaded with sediment. This site appears to be used to process water generated at the adjacent quarry in addition to stormwater. The facility in its current state cannot provide stormwater detention. There are no forebays to contain incoming sediment loads. Gravel is apparent in the sediment deposited in the basin.

**Existing Condition:** Dry basin showing wet conditions and sediment load

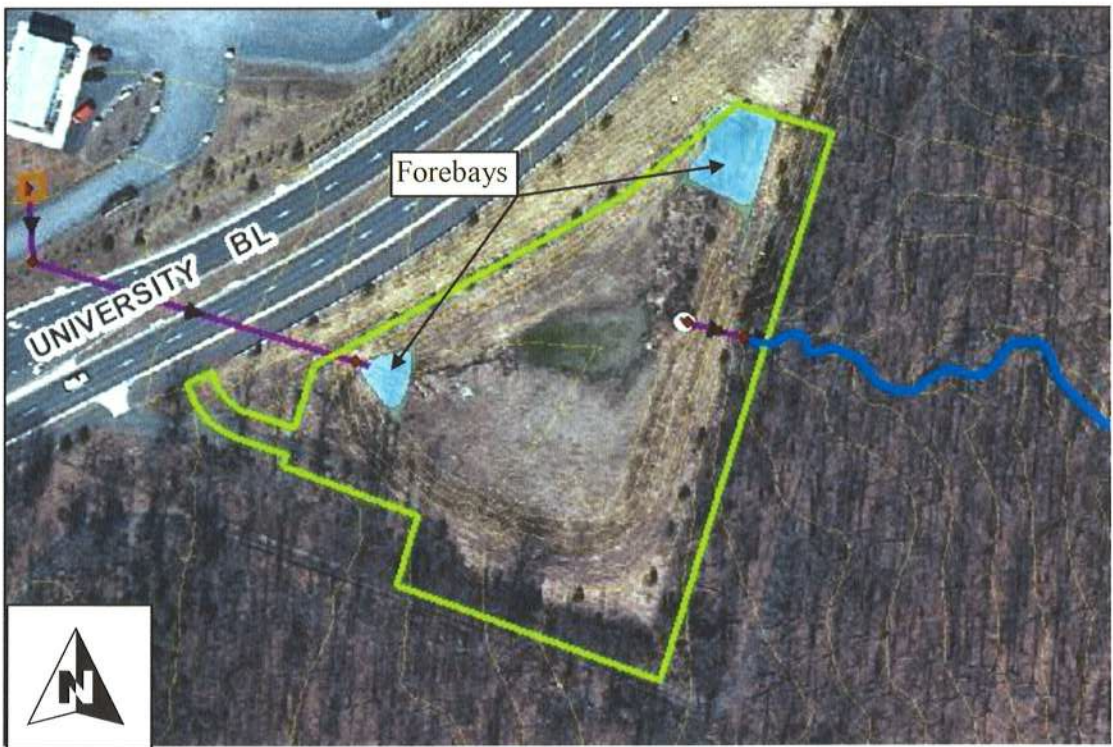
**Conceptual Plan:** Excavate sediment load and install forebays

**Project Description:** This facility appears to require a major renovation to remove the deposited sediment and provide a functional dry basin. If use of the facility by the quarry is going to continue to generate large sediment loads, then forebays should be installed to make removal more efficient.

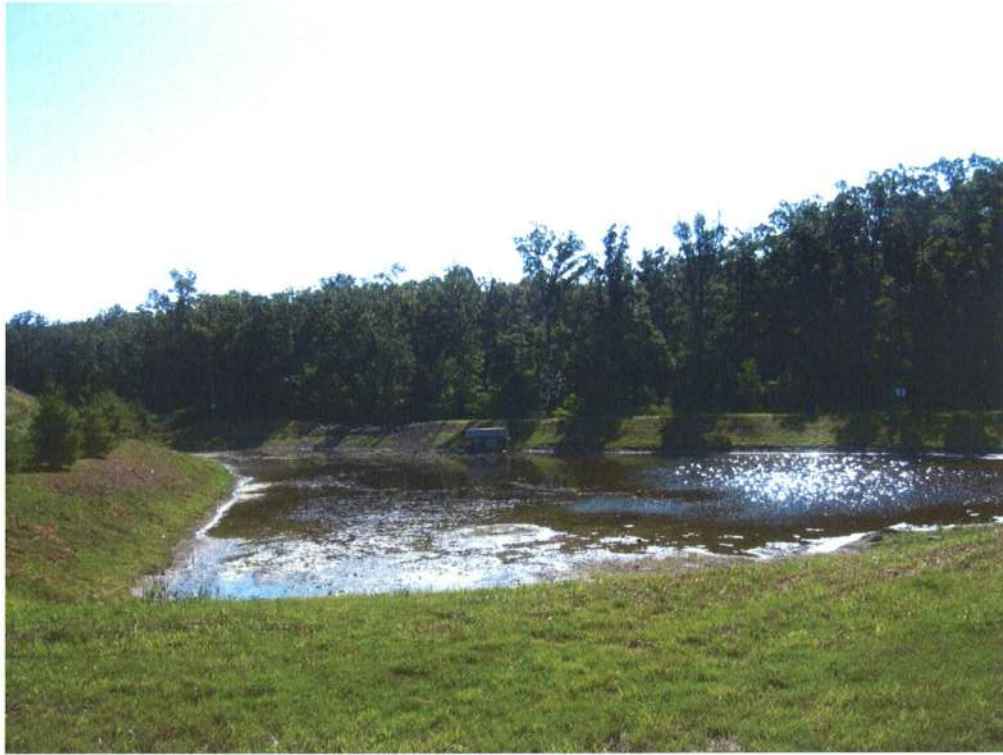
**Photo 1:** Site appears to be designed as wet pond, no forebays, and heavy sediment load

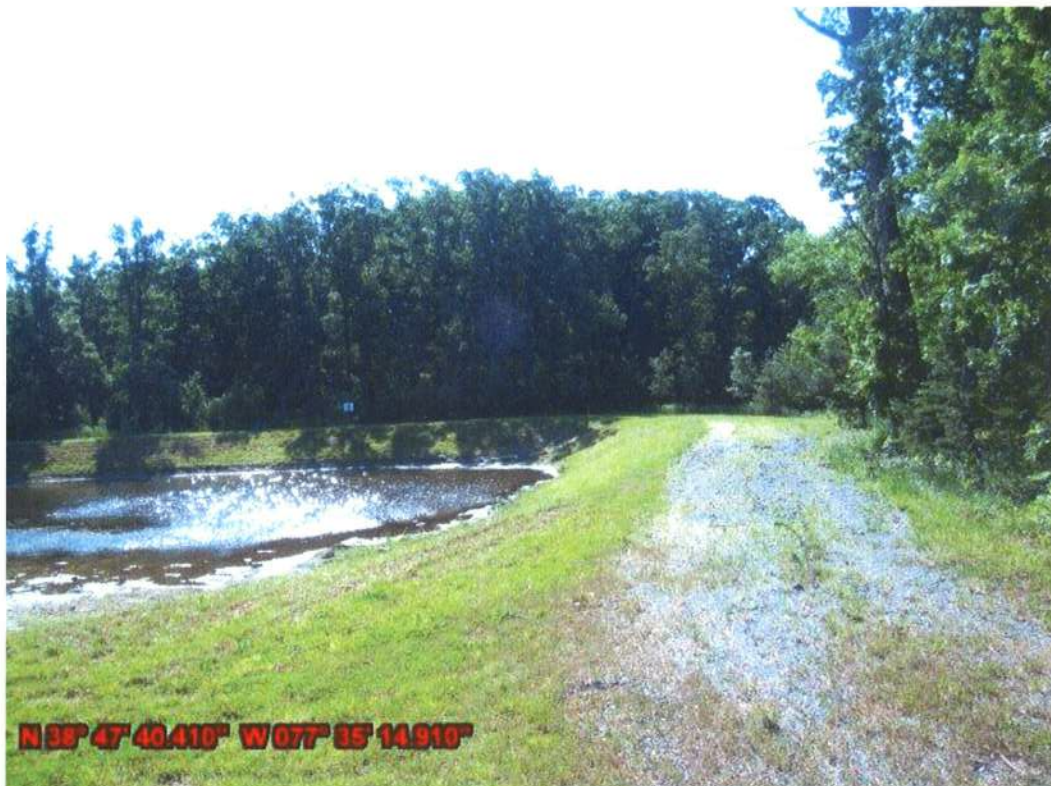
**Photo 2:** Service road provides easy site access for sediment removal
