**Marumsco Creek and Farm
Creek Watershed Coastal
Zone Improvement Projects**

MARUMSCO CREEK AND FARM CREEK WATERSHED MANAGEMENT PLAN

Stream Corridor Improvement Project

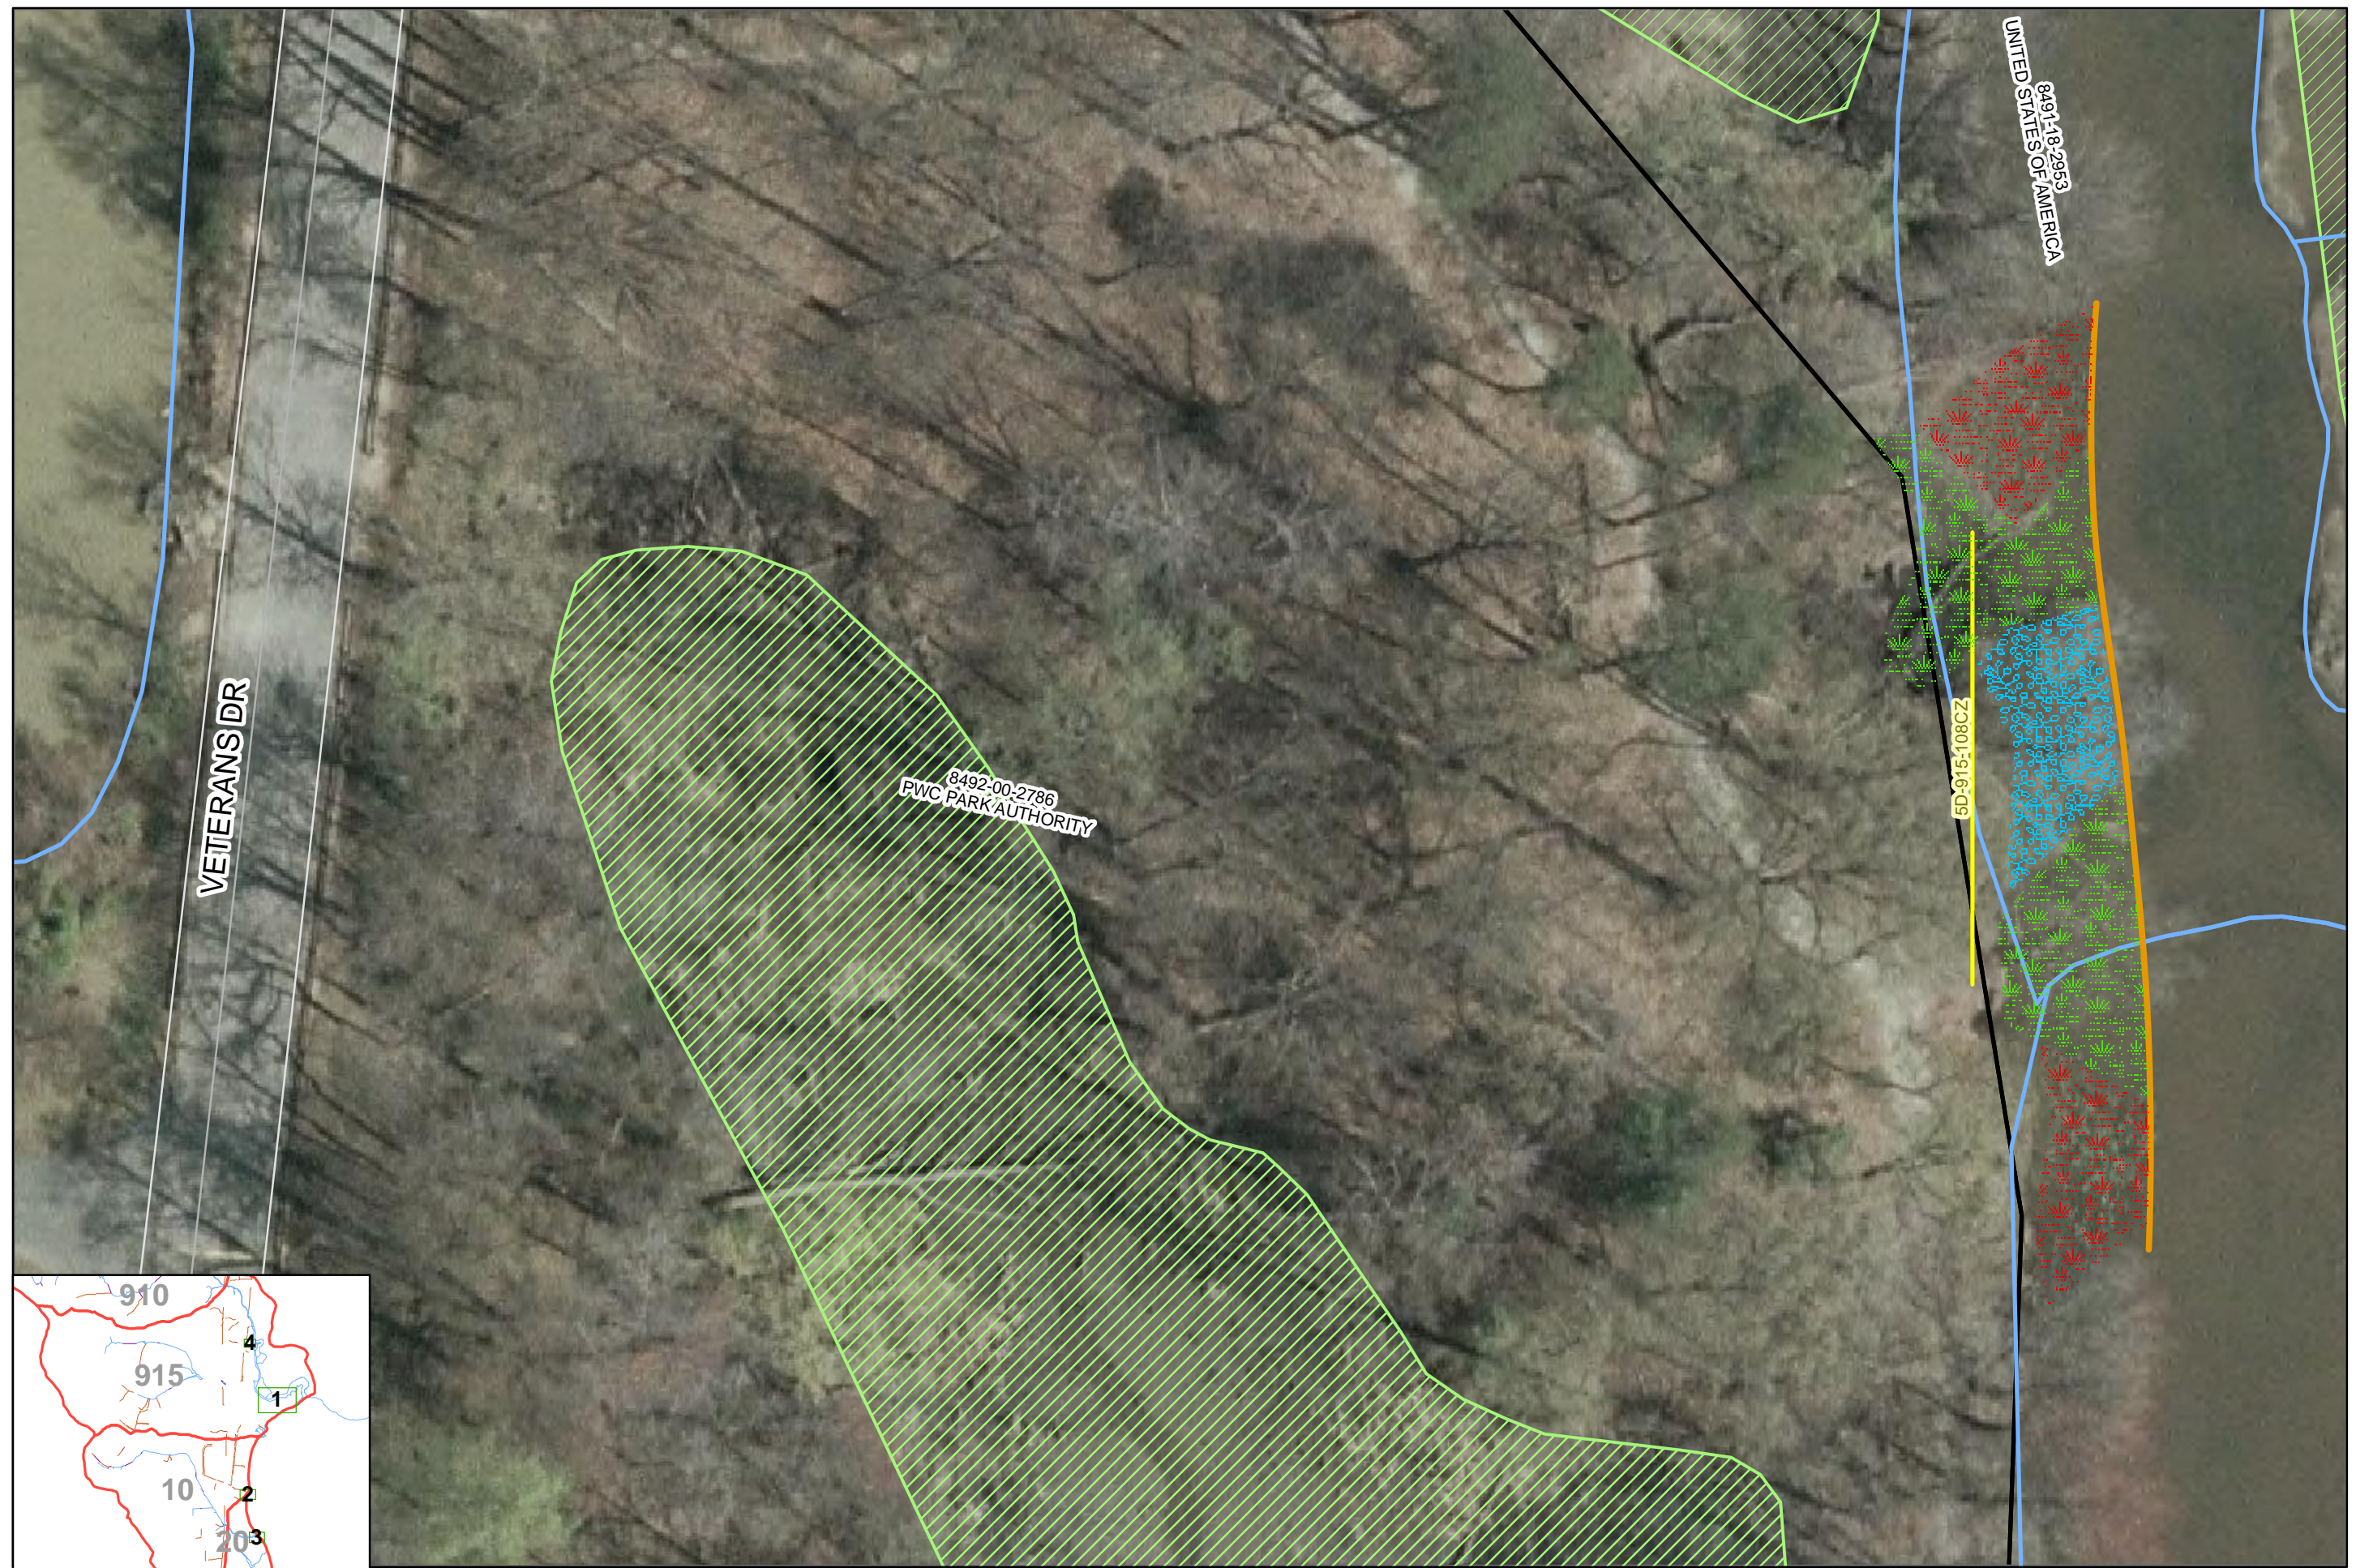
915-CZIP-01

Submerged Aquatic Vegetation Planting and Breakwater Construction

The project concept for this site involves the establishment of a soft breakwater structure with submerged aquatic vegetation (SAV) plantings between the breakwater and the shoreline. The soft breakwater structure is proposed to be constructed from coir fiber logs anchored to the channel bed. Types of SAV that can be considered for planting behind the breakwater include Eurasian watermilfoil, wild celery or eelgrass (depending on water salinity), sago pondweed, and horned pondweed. Additionally, small mudflats in the area can be enhanced with wetland plantings and existing nearby SAV areas are to be protected by installation of the breakwater.

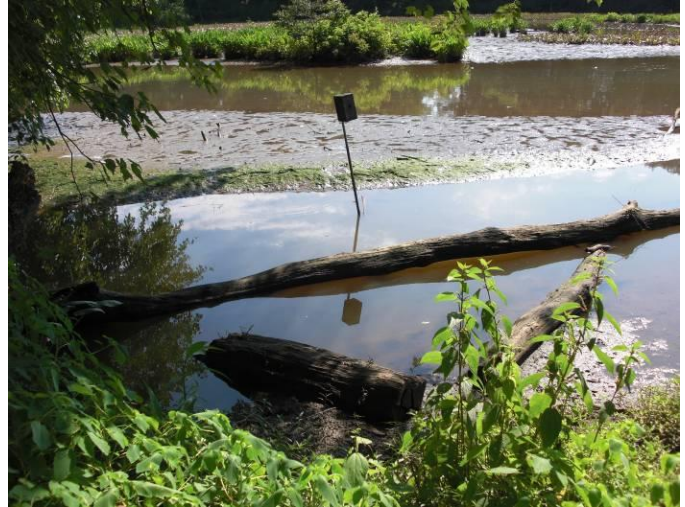
5D-915-108CZ

Right bank of Marumsco Creek
along the hiker trail in Veterans
Memorial Park.
6/30/2009

In this area of Marumsko Creek, a limited area of the shoreline of the creek is slightly degraded along the nature trail through the park. The degradation portion of the shoreline provides an opportunity to enhance the aquatic habitat of the stream and provides a potential community involvement project.

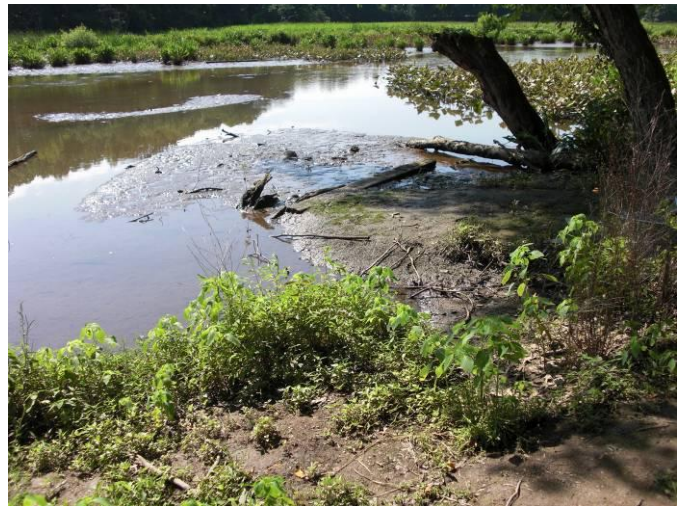
5D-915-108CZ

Right bank of Marumsco Creek
along the hiker trail in Veterans
Memorial Park.
6/30/2009

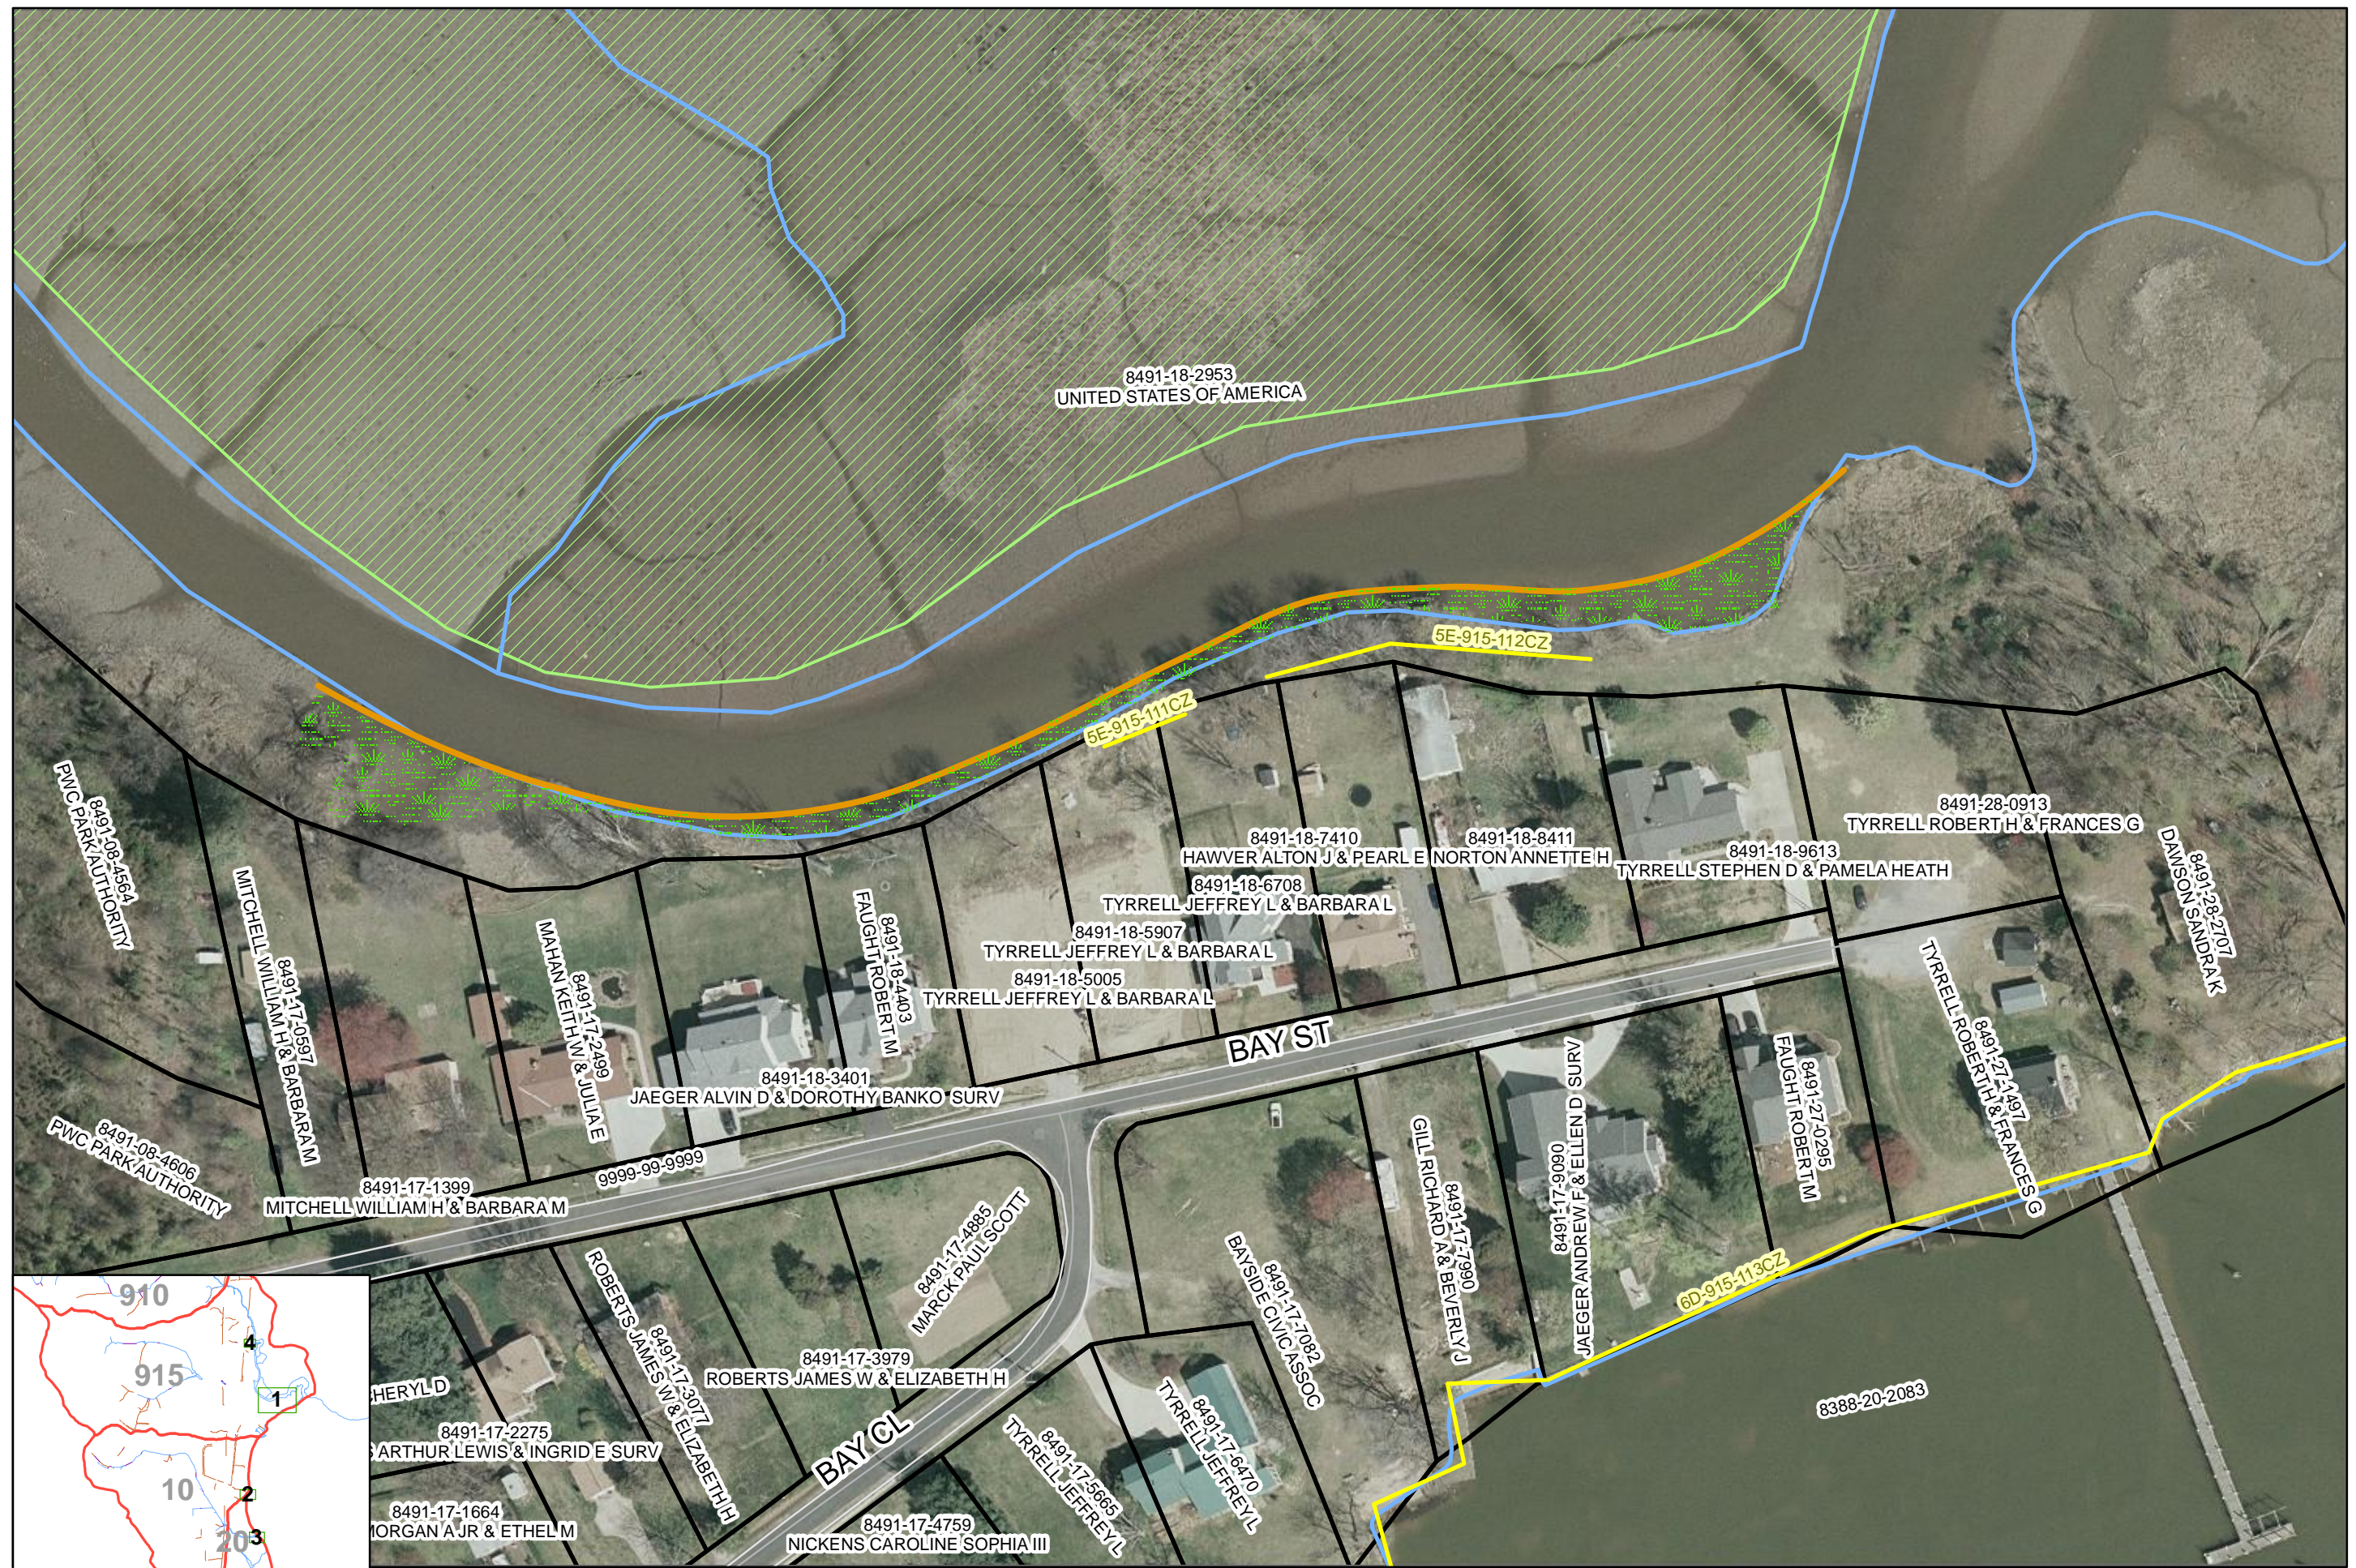
915-CZIP-02

Submerged Aquatic Vegetation Planting and Breakwater Construction

The project concept for this site involves the establishment of a soft breakwater structure with submerged aquatic vegetation (SAV) plantings between the breakwater and the shoreline. The soft breakwater structure is proposed to be constructed from coir fiber logs anchored to the channel bed. Types of SAV that can be considered for planting behind the breakwater include Eurasian watermilfoil, wild celery or eelgrass (depending on water salinity), sago pondweed, and horned pondweed.

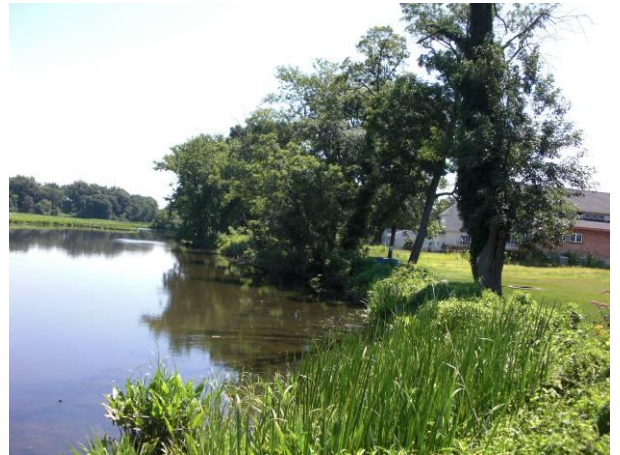
5E-915-112CZ

Right bank of Marumsco Creek behind Bay Street.

In this area of MarumSCO Creek, minimal buffer exists along the right streambank between the tidal portion of the creek and the private property. Degradation of the shoreline in this area has impaired habitat for native species of macroinvertebrates, reptiles, fish, and birds in this area. Additionally, the lack of a vegetated buffer allows for untreated stormwater runoff from the residential lawns to directly enter MarumSCO Creek.

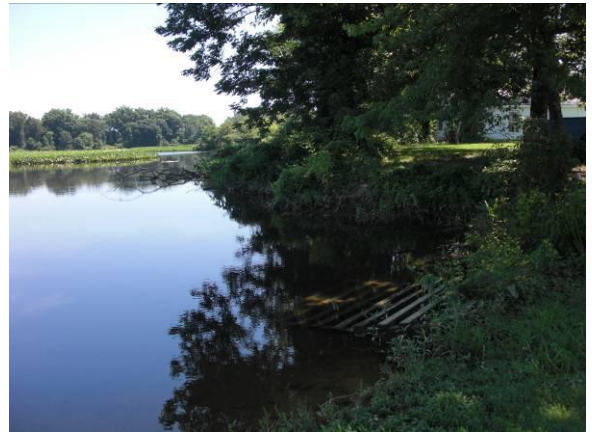
5E-915-112CZ

Right bank of Marumsco Creek behind Bay Street.

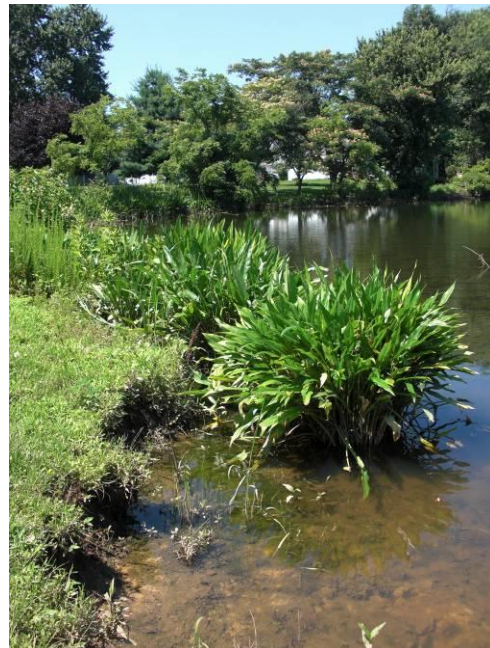
5E-915-112CZ

Right bank of Marumsco Creek behind Bay Street.

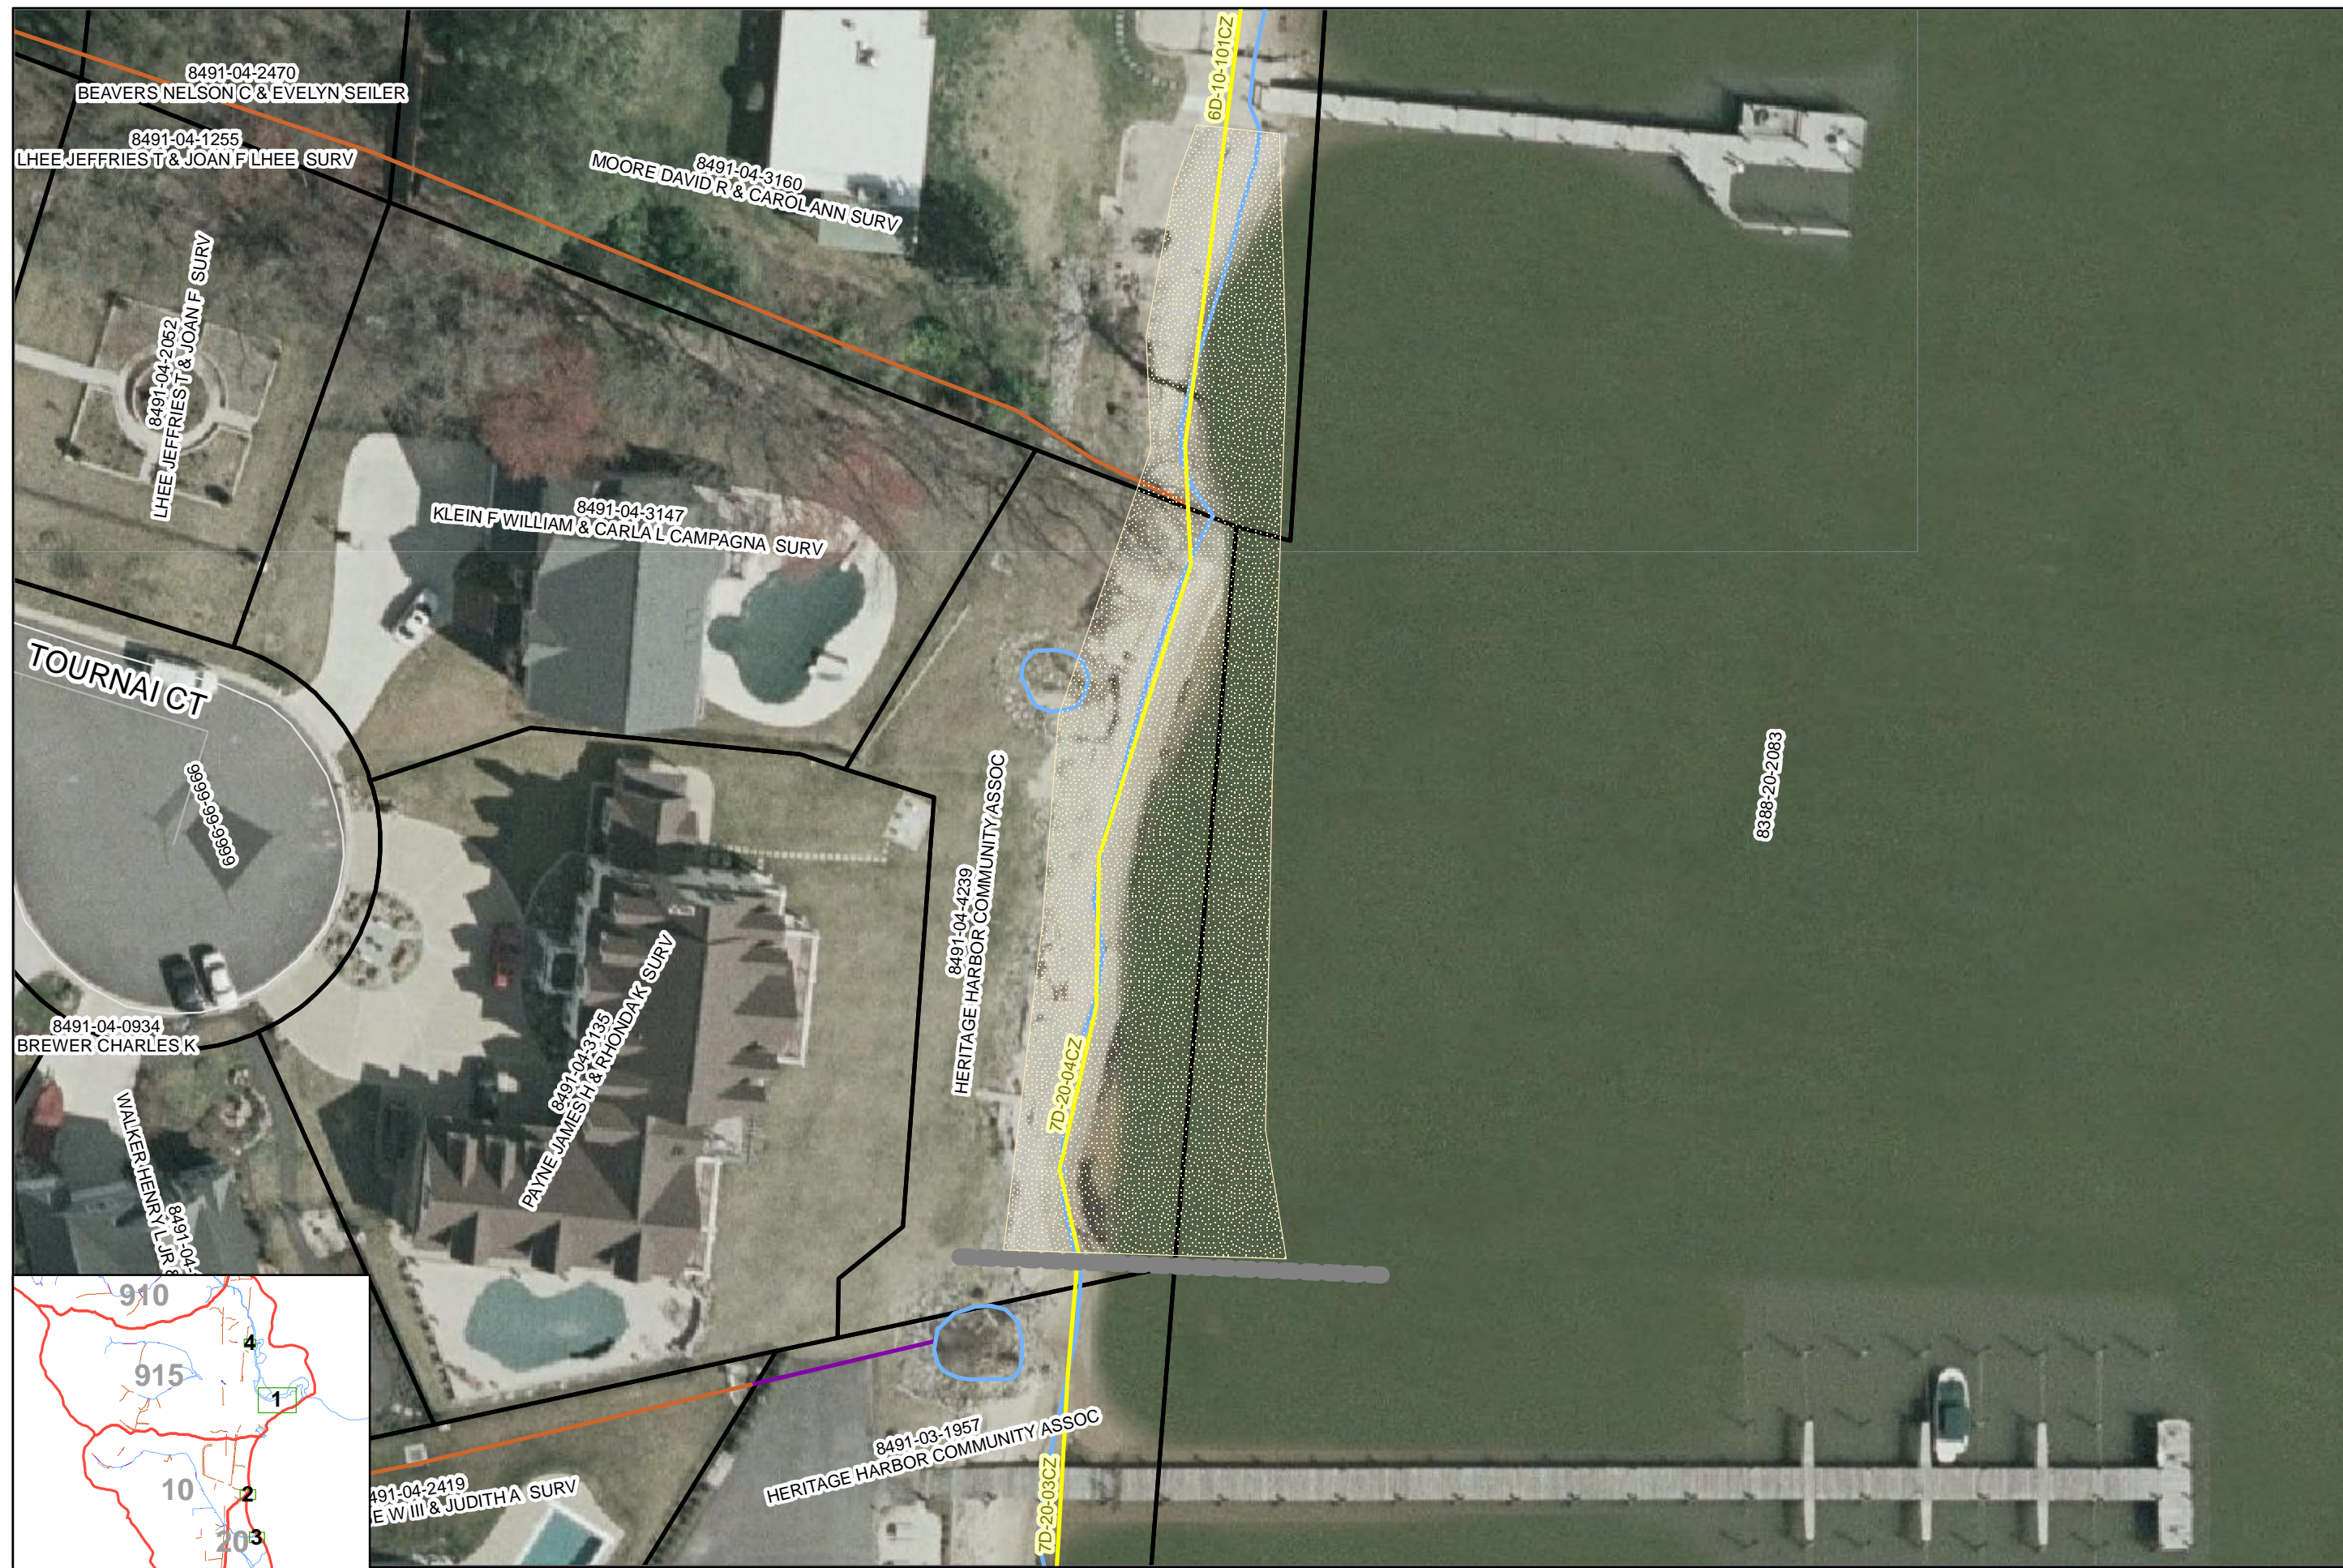
20-CZIP-03

Beach Nourishment

The project concept for this project site involves construction of a stone jetty along the southern boundary of the project and beach nourishment through sand pumping / placement along the nourishment area as shown. The stone jetty placement will allow for stabilization of the created beachhead and will prevent long-shore currents from pushing sands from the beach into the dock and boat ramp areas. Additionally, proper design of the jetty system along with presence of a sufficient sand sediment supply in the Occoquan Bay system will allow for the created beach system to be self-sustaining.

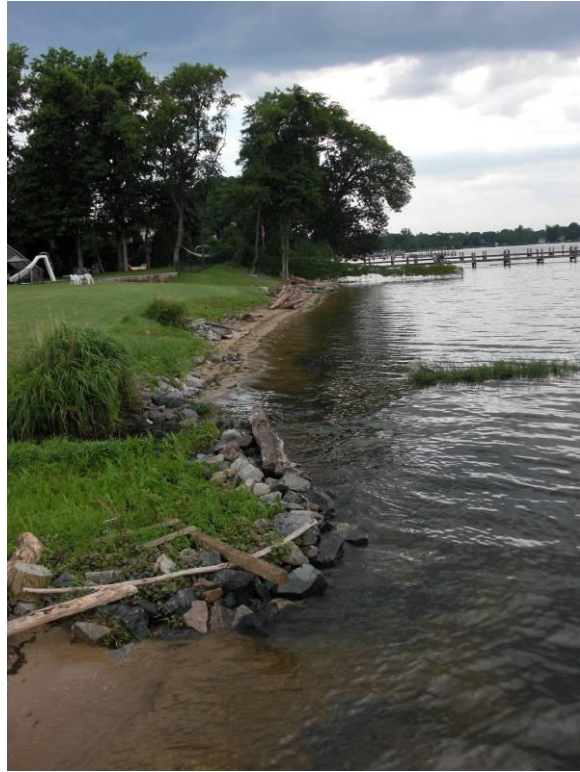
7D-20-04CZ

Limited beach area along the Occoquan Bay shoreline. Photo taken at high tide.
6/30/2009

This area is one of the few shorelines of the Occoquan Bay in this area that has not been artificially stabilized with wooden bulk head. Currently a limited beach front exists along the shoreline. The limited beach area has two storm drain outfalls that flow onto it and are bounded on both ends by timber boat docks. The southern end of the project is bounded by a concrete boat ramp.

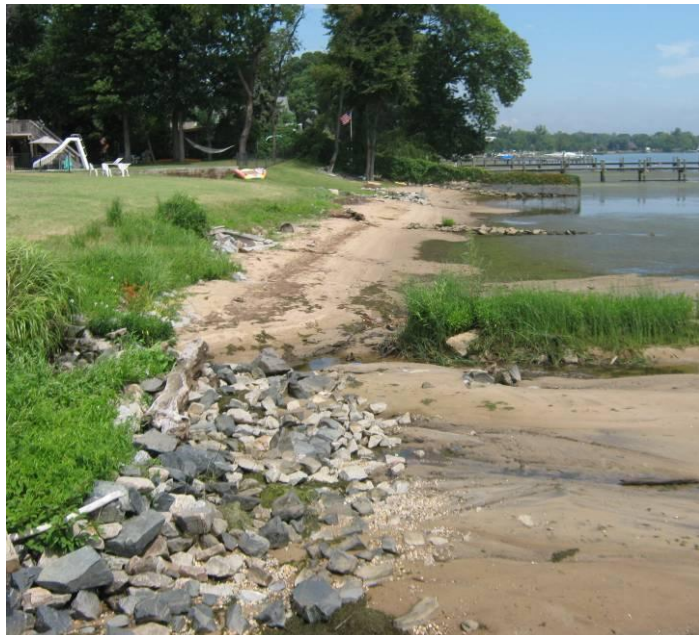
7D-20-04CZ

Limited beach area along the Occoquan Bay shoreline. Photo taken at low tide.
8/20/2009

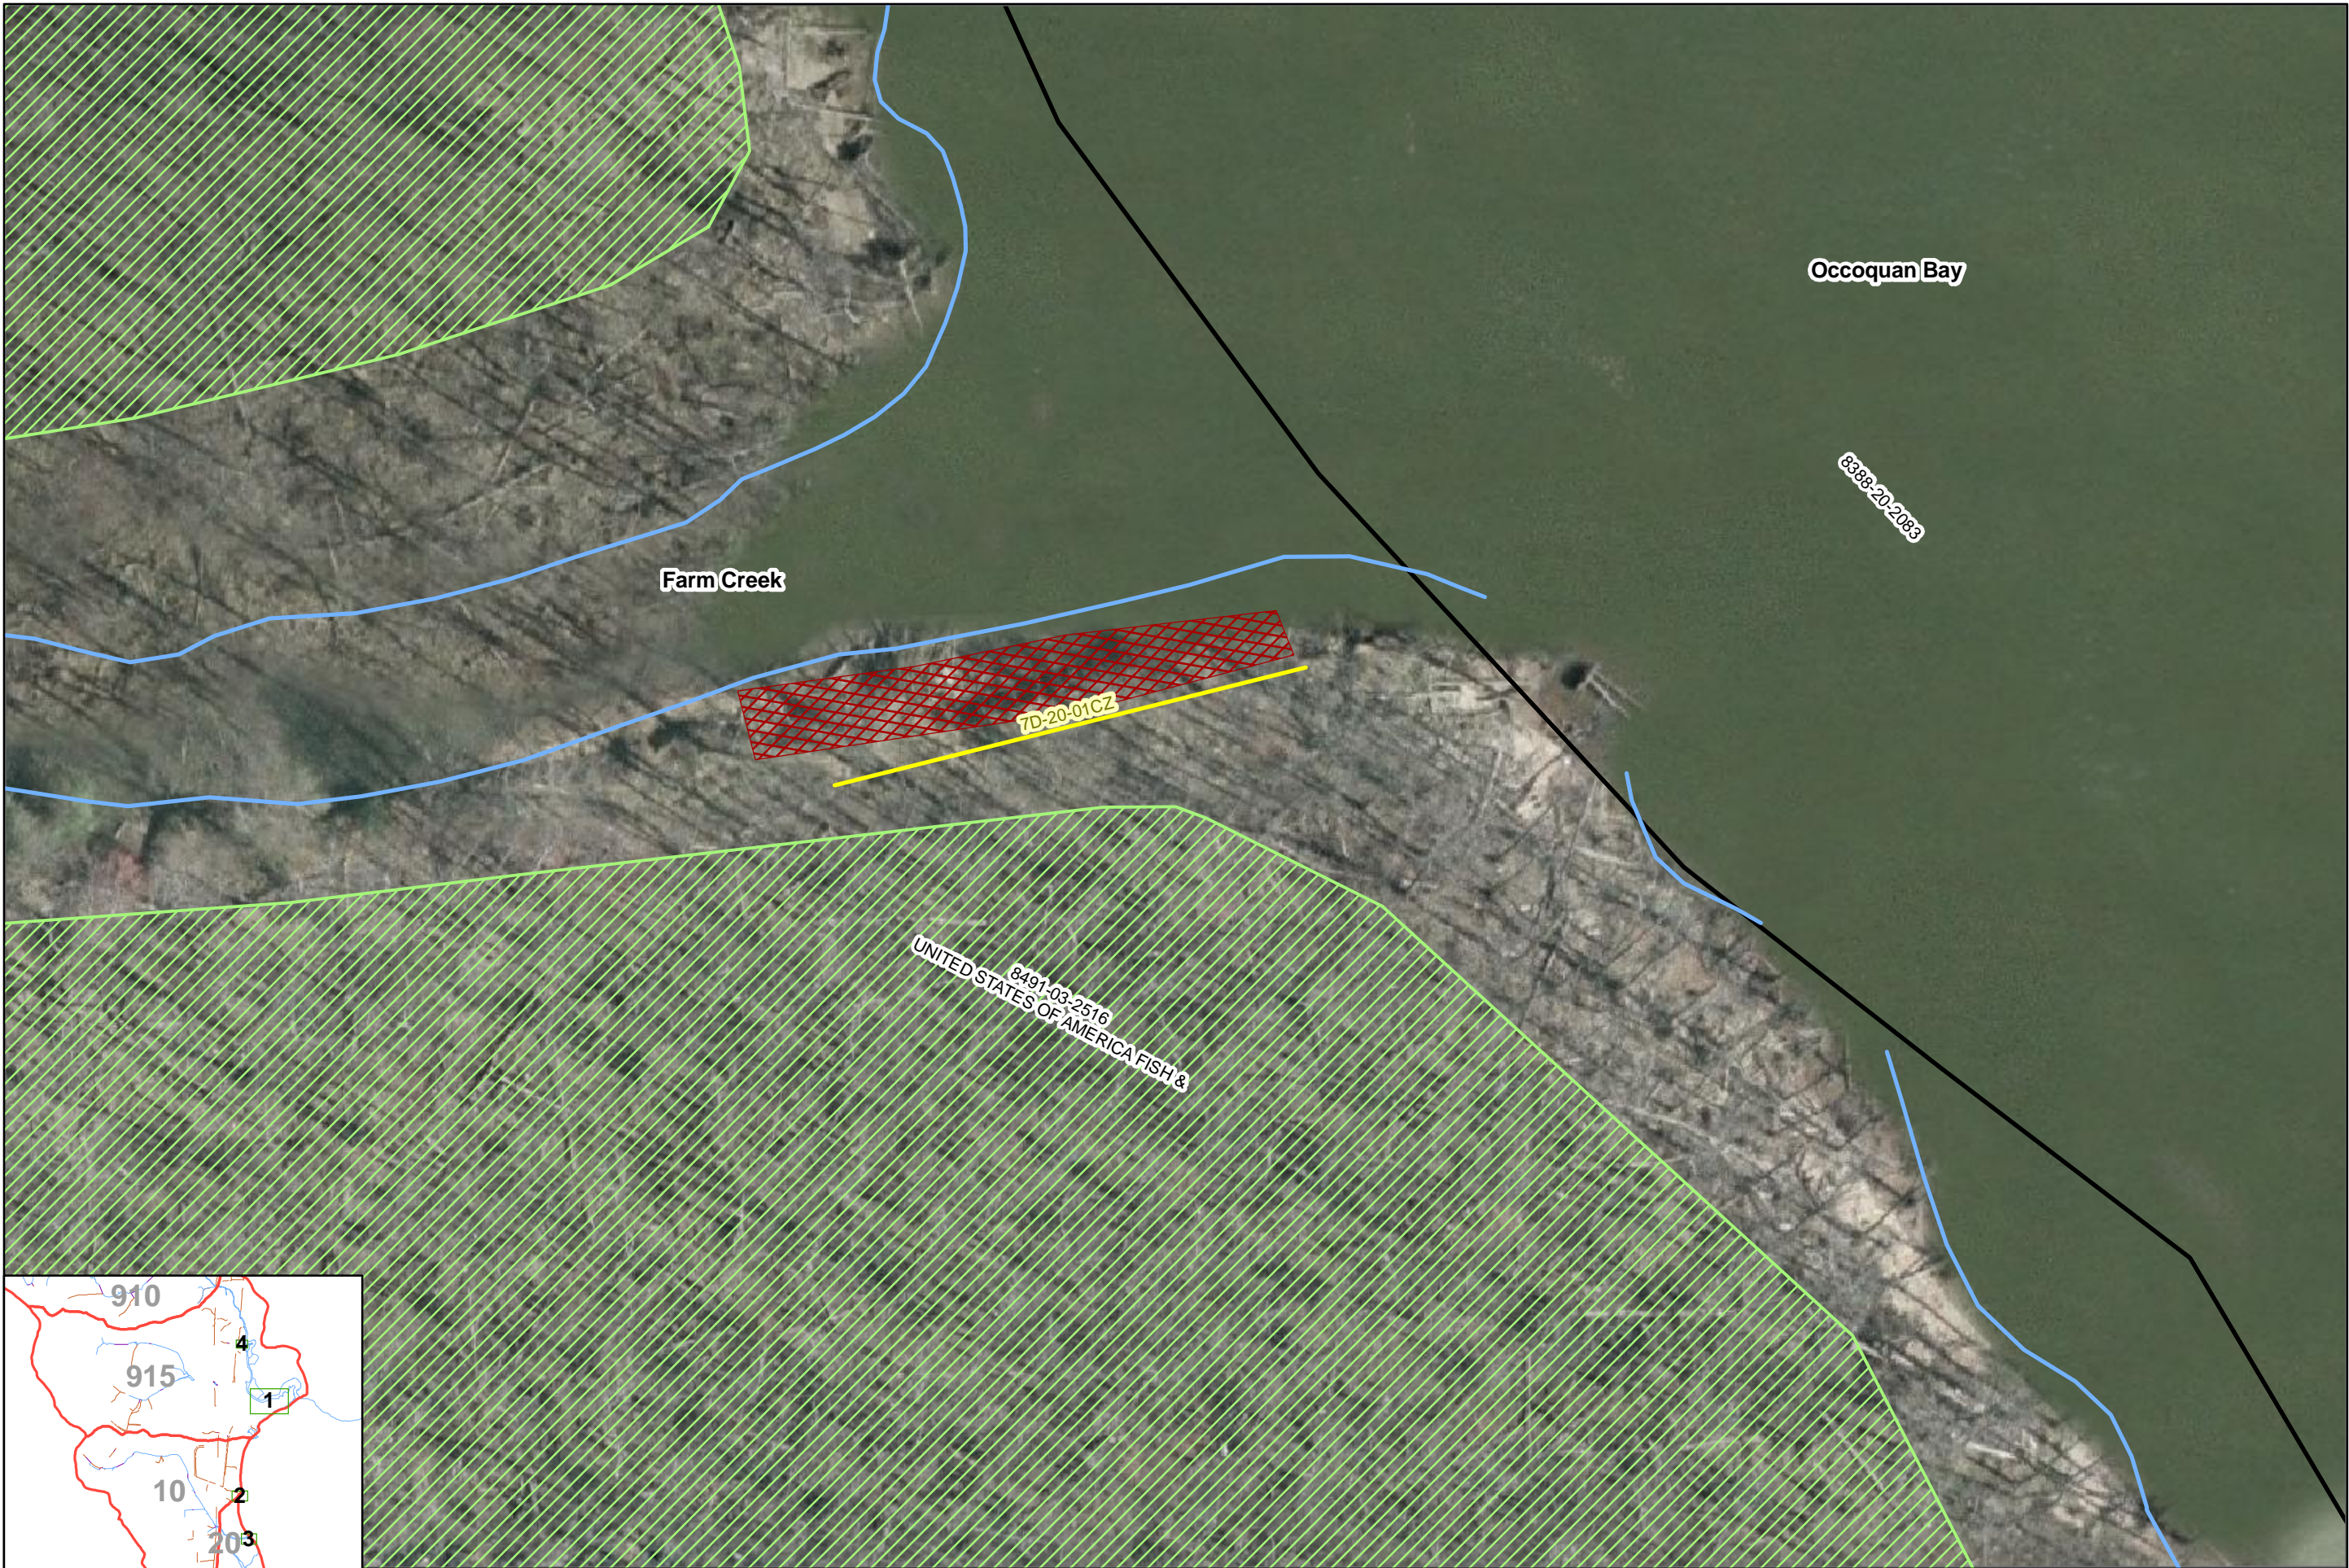
20-CZIP-04

Stream Bank Stabilization

The project concept for this project site involves stabilization of the streambank through grading and bioengineering / bank plantings.

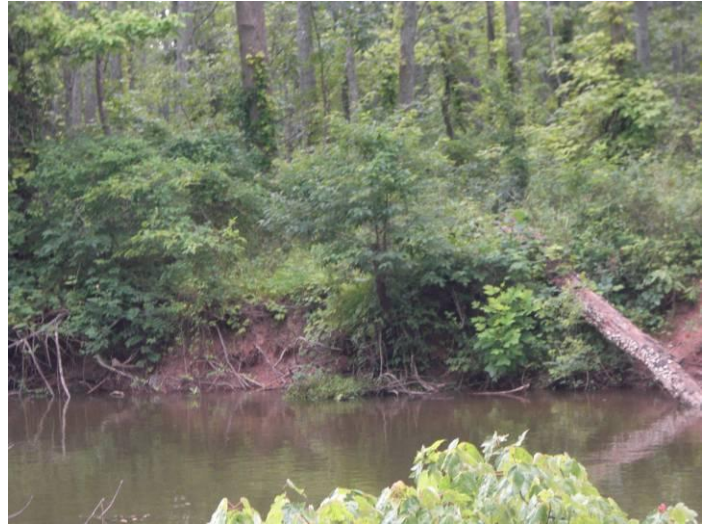
7D-20-01CZ

Right streambank of Farm Creek.
Erosion shown is estimated to be +/- 4
feet high above the high tide line.
6/30/2009

The right streambank of Farm Creek is eroding in this area. The bank erosion is estimated to be 4 feet high above the high tide level. A few trees have been undermined by the erosion and are falling into the estuary.

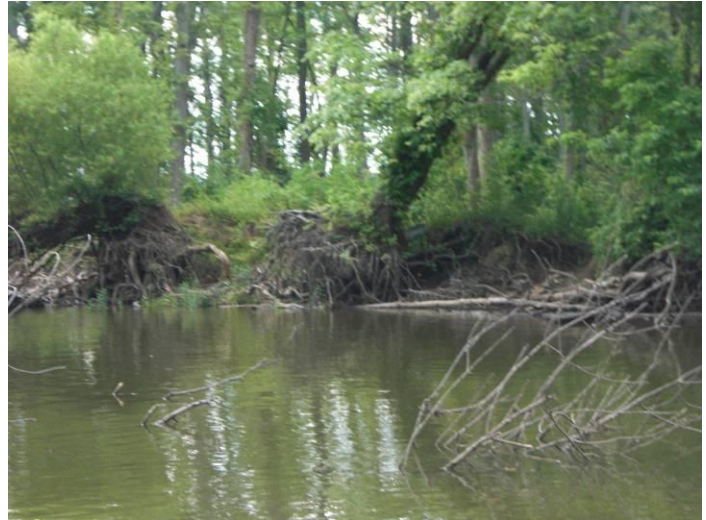
7D-20-01CZ

Right streambank of Farm Creek.
Photo shows undermining of trees
that are falling into the estuary.
6/30/2009

Natural Resource Conservation – Natural resources in the area are currently endangered or impacted by this destabilized system. Bank erosion is leading to the undermining and felling of trees, which in turn will lead to additional bank instabilities.
