PRINCE WILLIAM COUNTY PUBLIC SAFETY TRAINING CENTER

2019 MASTER PLAN UPDATE

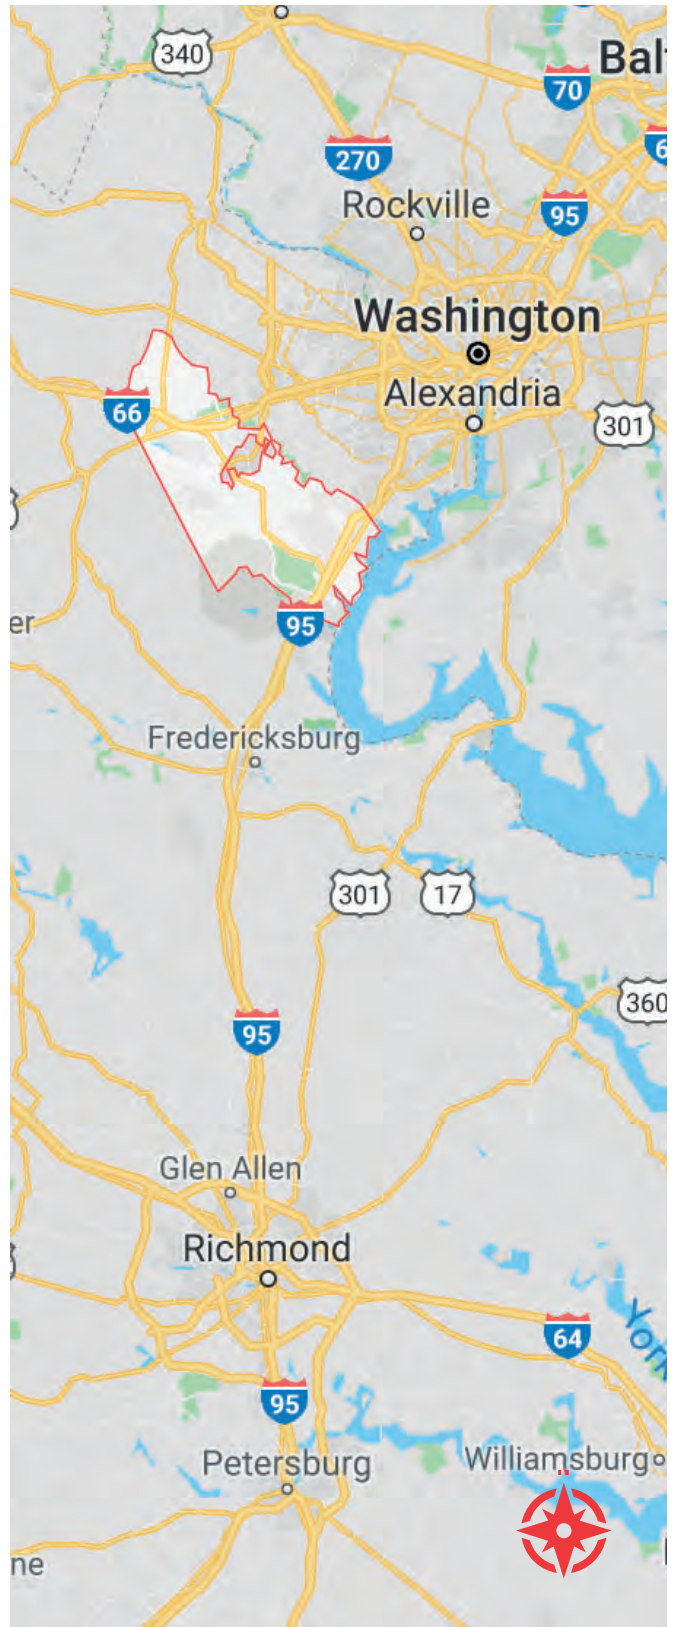
figure 1-1 | Regional Context

The Public Safety Training Center is approximately 45 miles from Washington DC and 85 miles from Richmond, VA. It is located in western Prince William County, as shown in Figure 1-1 Regional Context.

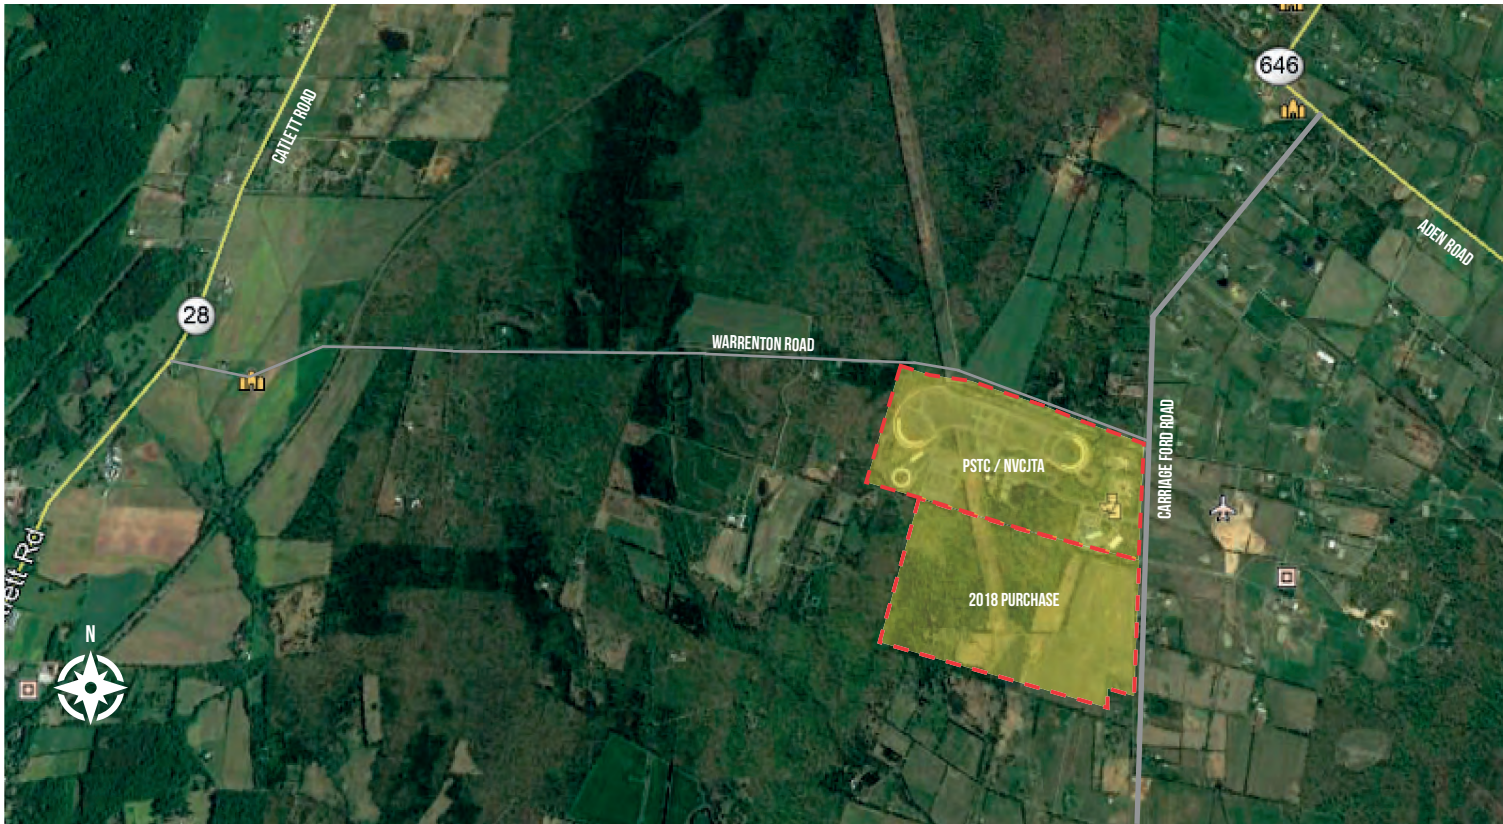
figure 1-2 | Project Location

Located at 13101 Public Safety Drive near Nokesville, Virginia, the site is approximately 18 miles west of the County Government Center, at the intersection of Warrenton Road (Route 606) and Carriage Ford Road (Route 607), near Nokesville, VA. The main access to the PSTC is located off of Carriage Ford Road. The closest concentration of commercial development is to the northeast, in Nokesville. The closest public transportation stop is approximately 6 miles away from the campus entry. The location of the PSTC is illustrated in Figure 1-2 Project Location.

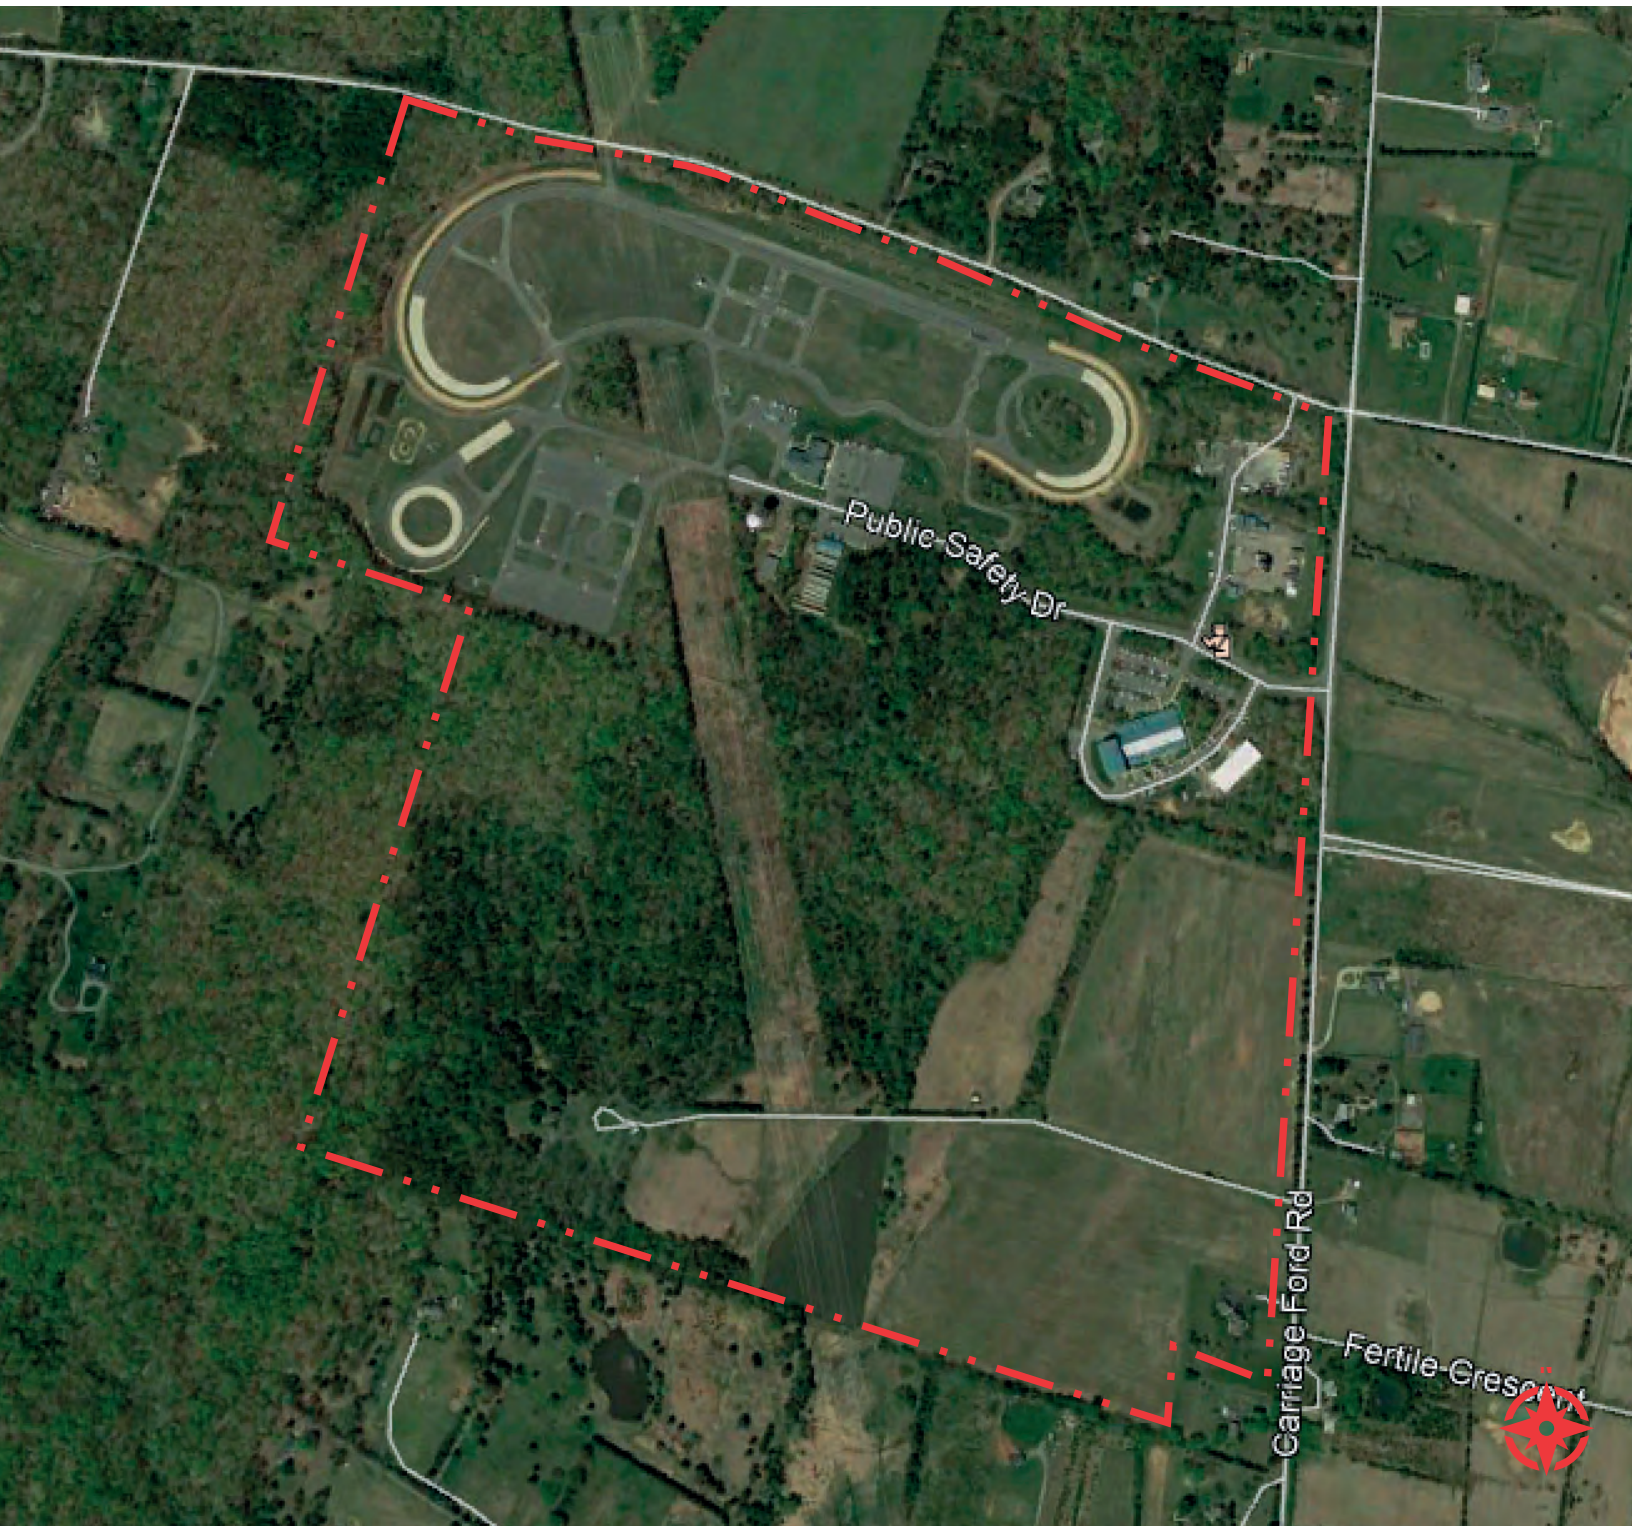
figure 2-1 | Existing Conditions

In 1987, the Northern Virginia Criminal Justice Training Academy (NVCJTA) purchased 139 acres of land in Nokesville and planned to relocate to the site. Instead, they relocated to Ashburn. They sold a portion of the property to Prince William County in 1991 for the construction of Prince William County's Public Safety Training Center (PSTC). The PSTC was always planned for phased development. The first phase, constructed in 1993, included the Joint Training Facility for Police and Fire and Rescue, the Burn Building, the Well House, the Range Building, and the Firing Range. Subsequent phases of construction on the PSTC site included the Shoot House, the Burn Pad, the modular Training Building, and the Trench Simulator. The Emergency Vehicle Training Center (EVOC) was constructed in 2010 on property retained by NVCJTA adjacent to the PSTC site to serve as a joint training facility between NVCJTA and PWC. An aerial view of the existing site development, including the April 2018 purchase, is shown in Figure 2-1, Existing Conditions.

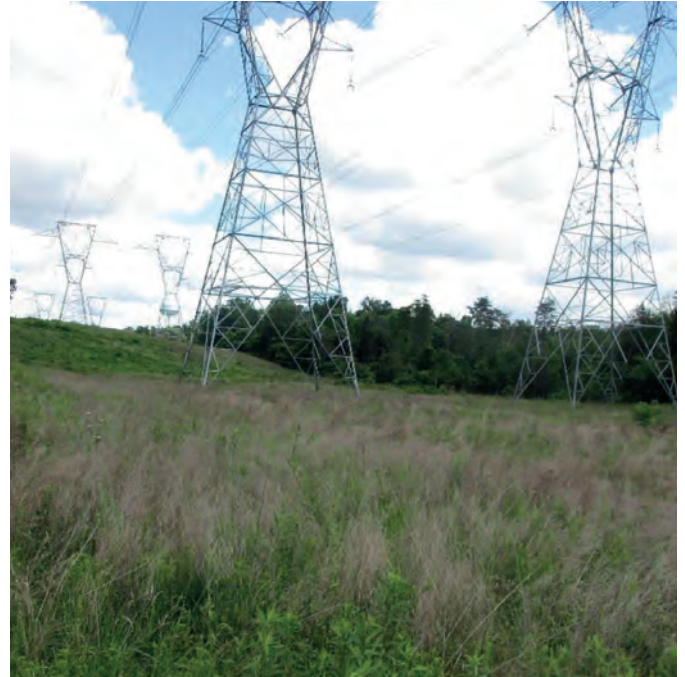
figure 2-2 | High Voltage Transmission Lines

corner running southwest towards the southern property boundary where it crosses the property line and exits the site (see figure 2-2) The overhead transmission line crosses the EVOC portion of the property and continues south-southeast through the property owned by Prince William County. The overhead transmission line continues onto the adjacent property to the south. The overhead transmission lines are within an existing 240' wide easement owned by Dominion Virginia Power (DVP). These transmission facilities are used to transmit power throughout the region and are not available to provide power directly to the site. In addition, terms of the easement state that while surface paving is allowed within the 240' width, structures are not. The location of the easement impacts future site development. The current uses on the site are served by a variety of underground and overhead electric lines operated by Dominion Virginia Power which are being fed from an existing overhead power line near the intersection of Warrenton Road and Carriage Ford Road and running along Public Safety Drive. A natural gas transmission line in a 30' gas easement runs parallel to the overhead electric transmission lines on the western side overlapping the electric transmission easement. The natural gas transmission line is a high pressure pipeline which is available to commercial use and cannot be used to provide natural gas to the site. There is an existing propane tank farm on site just southwest of the existing modular building. The existing propane tanks serve the temporary modular building. The major natural gas suppliers for the area are Columbia Gas and Washington Gas.

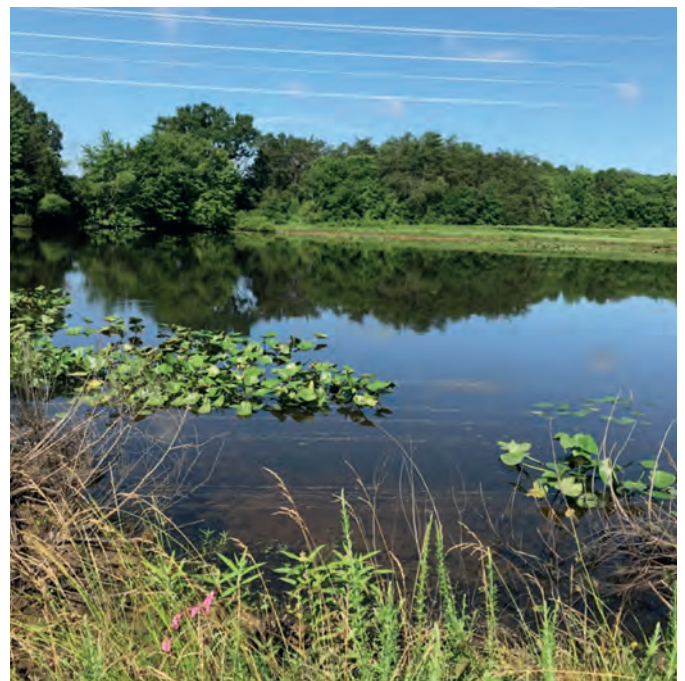
figure 2-3 | Farm Pond

Safety Drive and grass areas. The site contains some wetlands, ponds, streams and a large farm pond. The campus slopes generally from west to southeast, rolling toward the existing streams and farm pond at the southern boundary of the site (see figure 2-3). Carriage Road is fairly flat along the parcel frontages. The campus varies in elevation by about 64 feet from the highest point to the lowest point. See Figure 2-6 Topography.

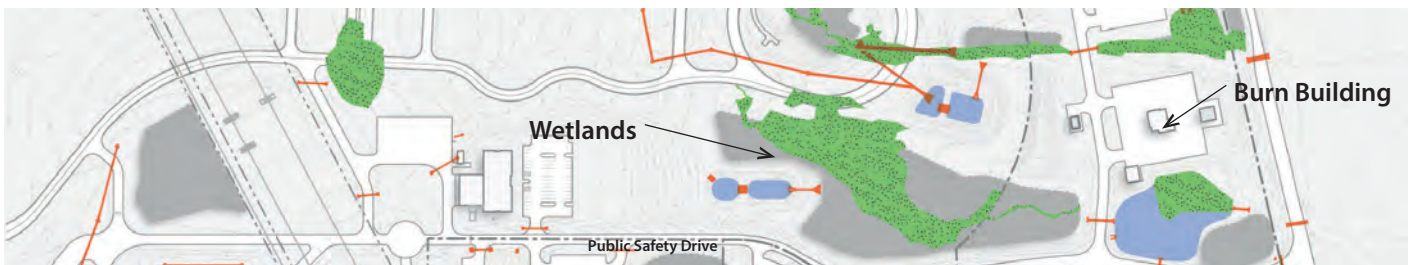
figure 2-4 | Hydrology 2014 Master Plan; north of Public Safety Drive (image credit HGA)

The 2014 Master Plan delineated and approximated wetlands are shown in Figure 2-4 Hydrology 2014 Master Plan. The delineated and approximated wetlands and streams on the recently acquired parcels are shown in Figure 2-56 Hydrology.

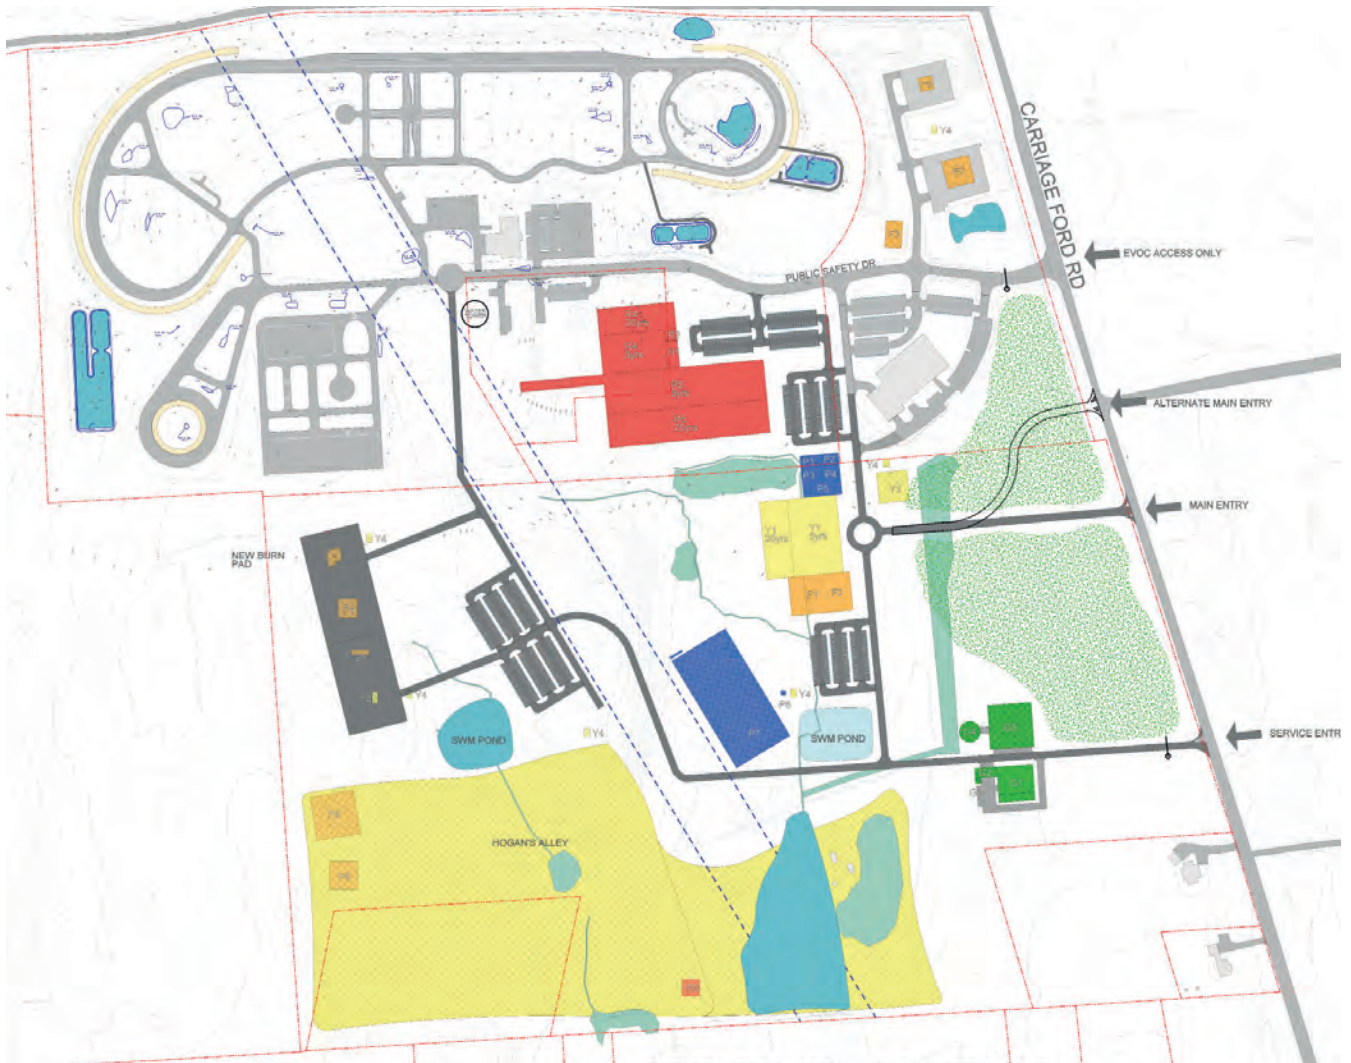
figure 3-2 | 2019 Master Plan

The Master Plan developed addresses the considerations enumerated above. The plan is described in detail in Chapter 5.

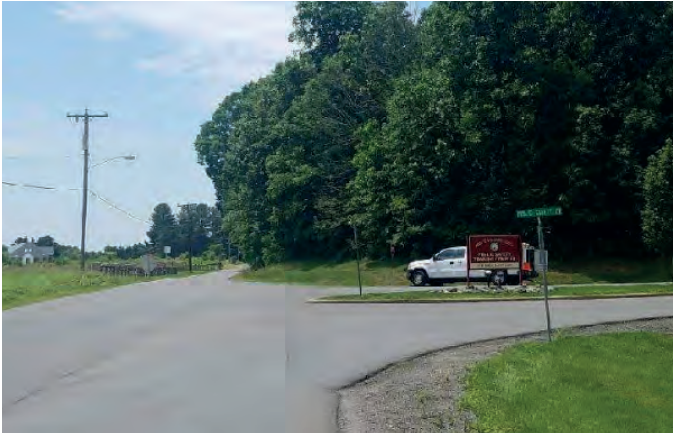
figure 3-5 | Public Safety Drive at Carriage Ford Road

Near its intersection with Public Safety Drive, Carriage Ford Road widens to facilitate a deceleration lane in the southbound direction (see figure 3-5). The deceleration lane extends for a distance of approximately 450 feet. No additional striping is provided in conjunction with the deceleration lane. The total pavement width near the site on the north side of the intersection is approximately 42 feet. On the southside of the roadway, while the corner radius facilitates right turns for larger vehicles, there is no acceleration lane. The pavement width on the southside of Public Safety Drive is approximately 20 feet.

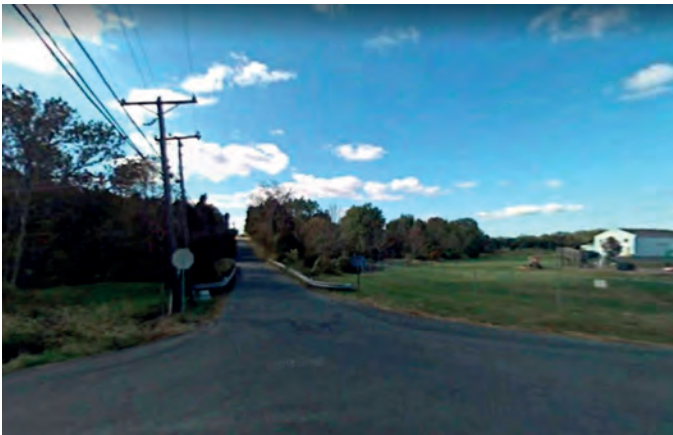
figure 3-6 | Carriage Ford Road at Aden Road

Carriage Ford Road is accessed from Aden Road, also a two lane road but classified by VDOT as a Rural Major Collector. At the intersection of Carriage Ford Road and Aden Road, Aden Road carries 4,000 VPD according to 2012 VDOT Traffic Count Data. Traffic turning onto Carriage Ford Road from Aden Road crosses an existing narrow two lane bridge to cross an existing stream (see figure 3-6). The County recognizes the inadequacy of the existing intersection and bridge and the need for a separate Capital Improvement Project to improve this intersection. An analysis will need to be completed on Aden Road and Carriage Ford Road in order to determine turn lane requirements at the intersection and the impacts to the existing bridge. Improvements associated with this intersection and the existing bridge should be part of a separate Capital Improvement Project through Prince William County.

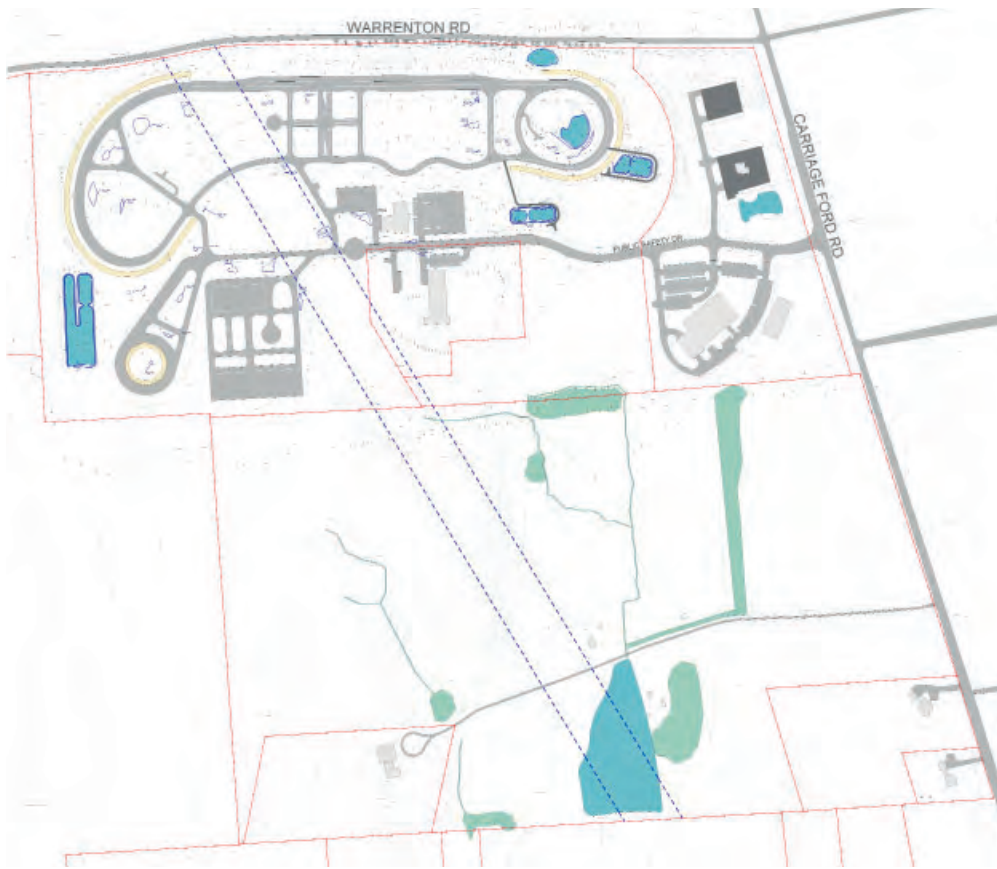
figure 5-1 | Existing Conditions

For reference, on the following pages the existing conditions are rendered in light gray as depicted in the image on the left. Where planned for demolition, buildings are shown with dashed outlines.

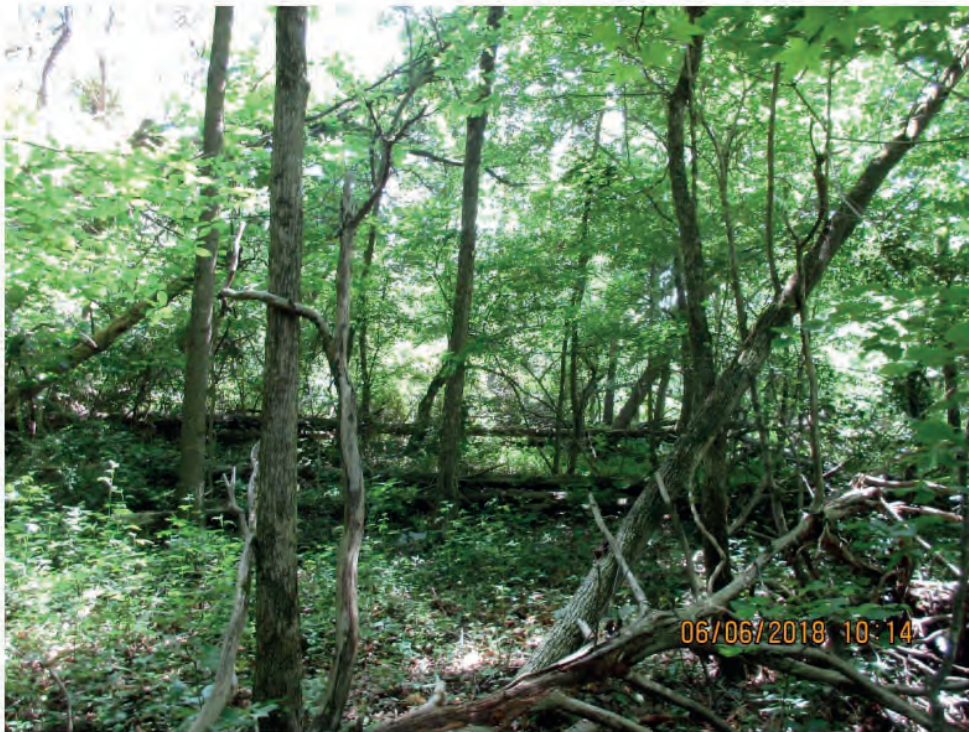
24. Looking east at the hardwood forest west of the easement in the western portion of the study area. The dense herbaceous cover and heavy large woody debris and woody vine presence make this area “low-quality” habitat for small whorled pogonia.

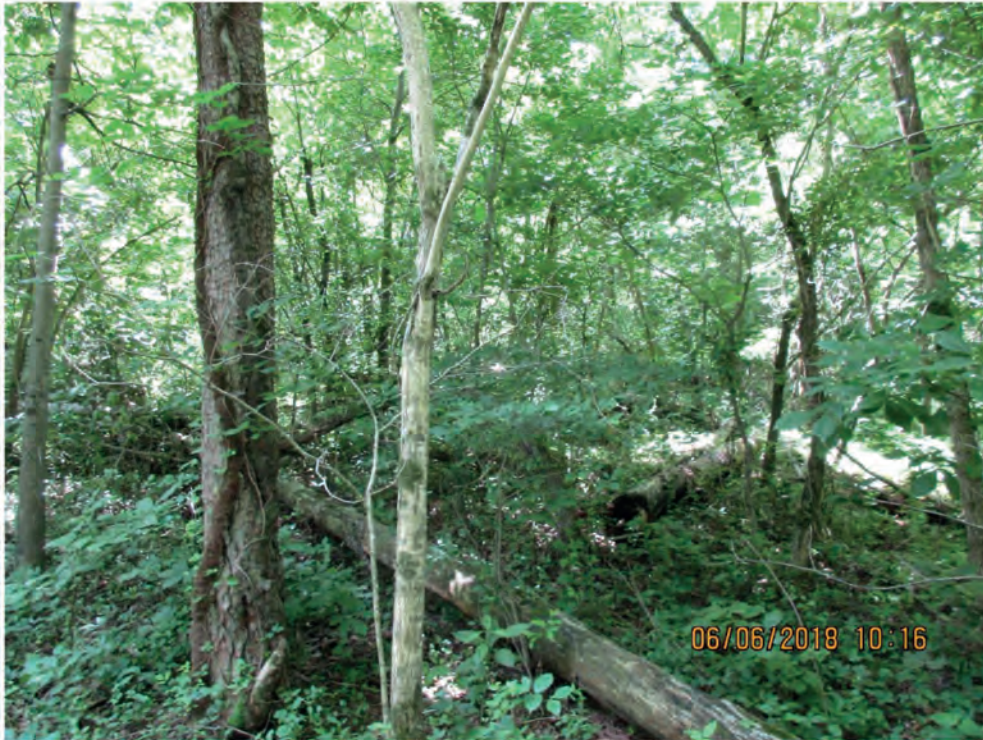
25. Looking southeast at the hardwood/cedar forest west of the transmission easement in the western portion of the study area. A lack of sunlight penetrating to the forest floor and dense herbaceous ground cover make this area “low-quality” habitat.

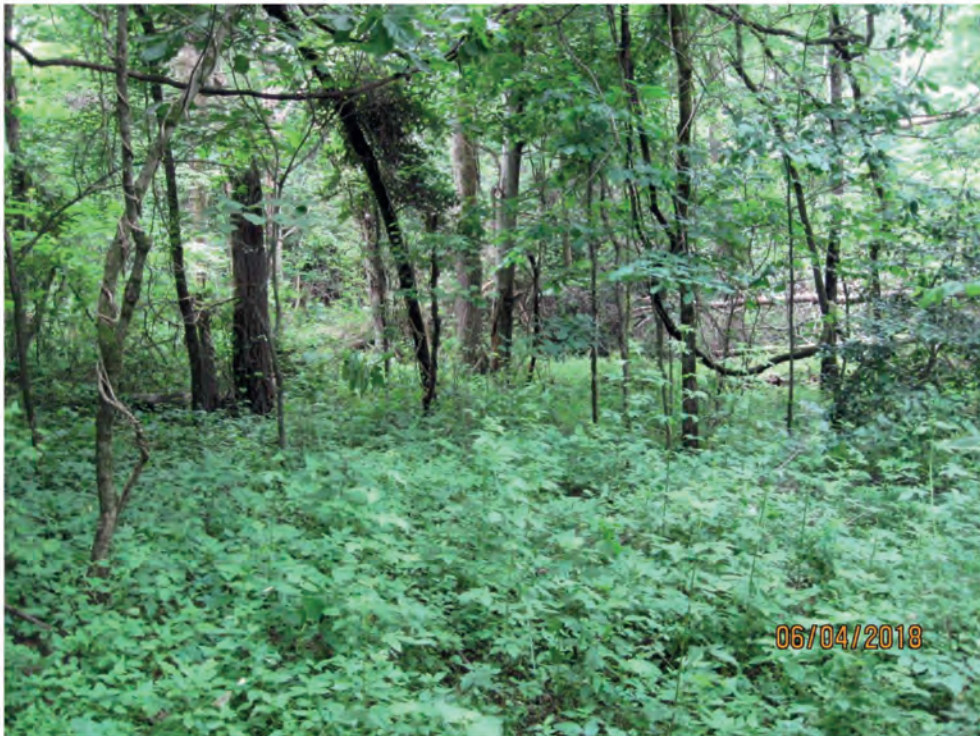
26. Looking south at the forest between the stream and transmission easement in the western portion of the study area. Though some sunlight is reaching the forest floor, herbaceous ground cover is very thick. This area is considered “low-quality” habitat.

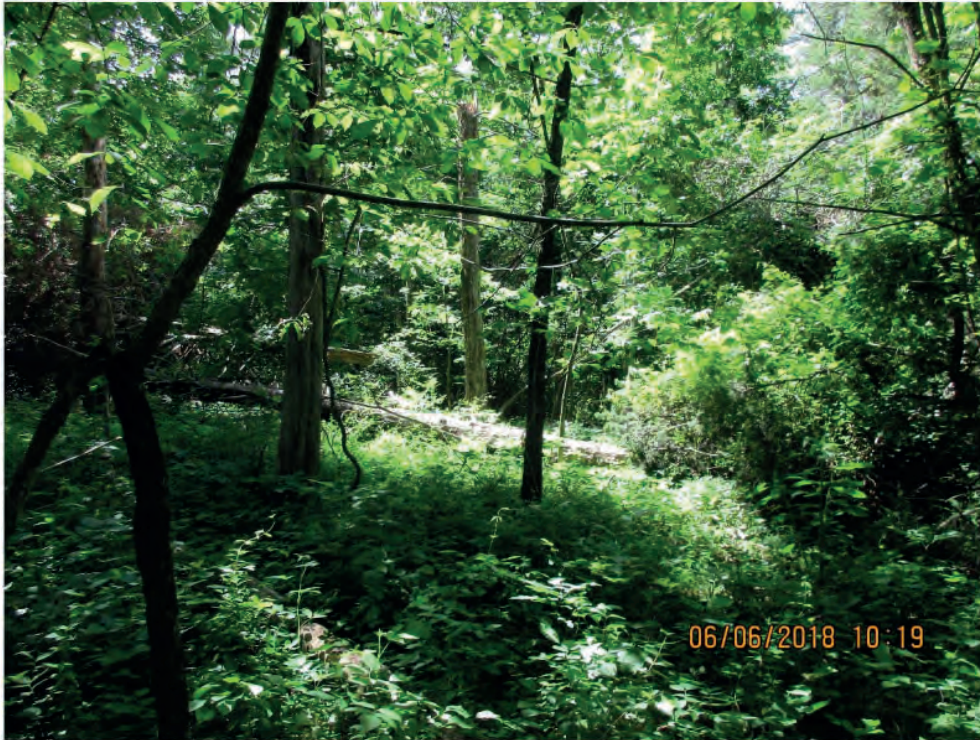
27. Looking southeast at the mixed forest in the central portion of the study area. Though associate species are present in the canopy, the thick herbaceous ground cover makes this area “low-quality” habitat.

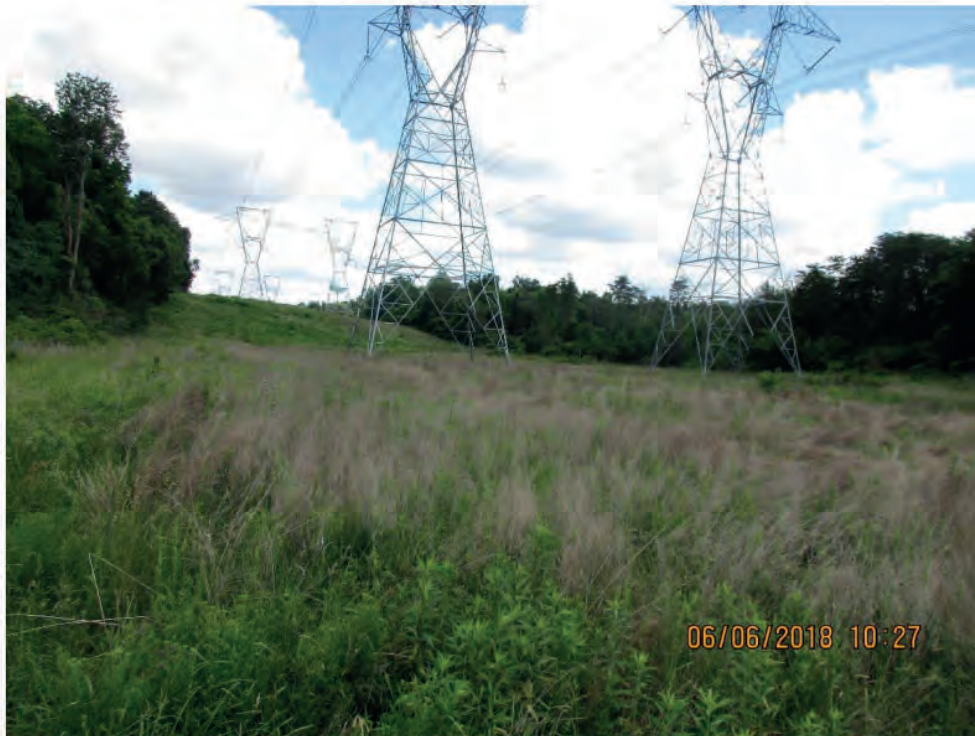
28. Looking north at the transmission easement present in the center of the study area. Because the area lacks forest cover, it is not suitable small whorled pogonia habitat.

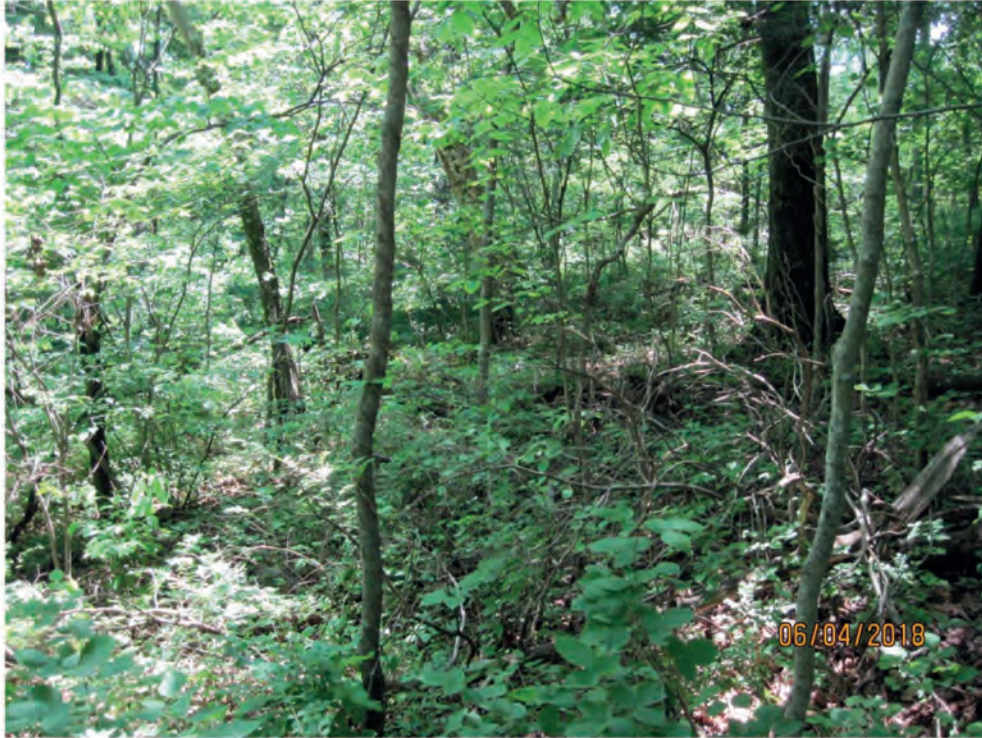
29. Looking south at the forested hillslope in the northern portion of the study area. Dense herbaceous ground cover and a thick midstory qualify this area as “low-quality” habitat.

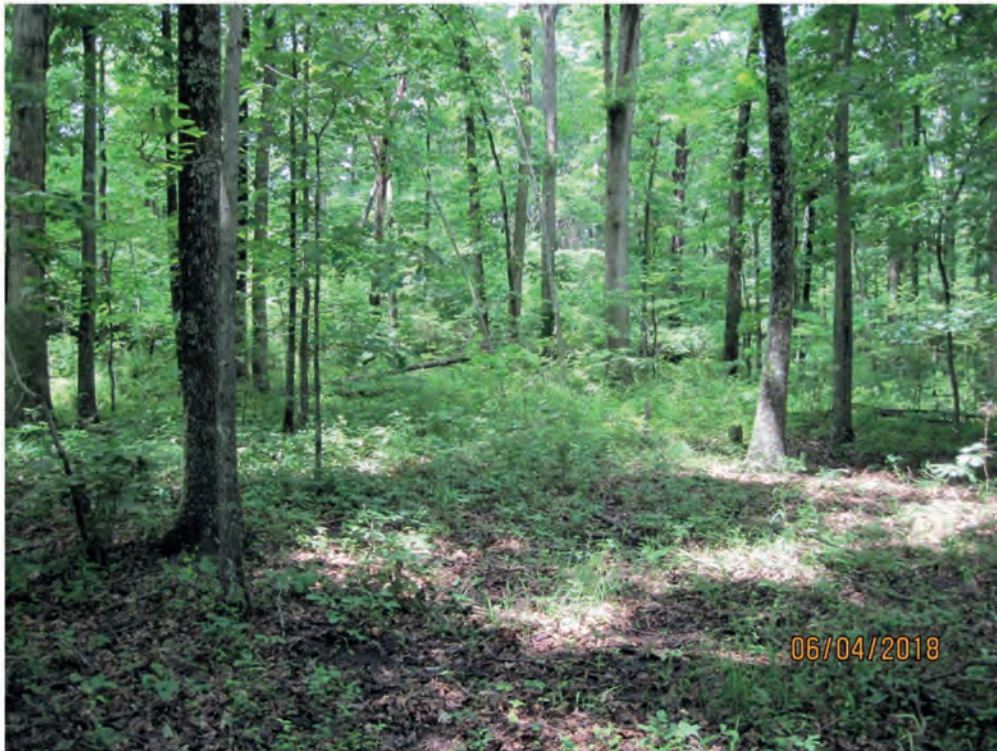
30. Looking northeast at the hardwood forest present in the eastern portion of the study area. The area is very wet and has dense herbaceous ground cover, making it “low-quality” small whorled pogonia habitat.

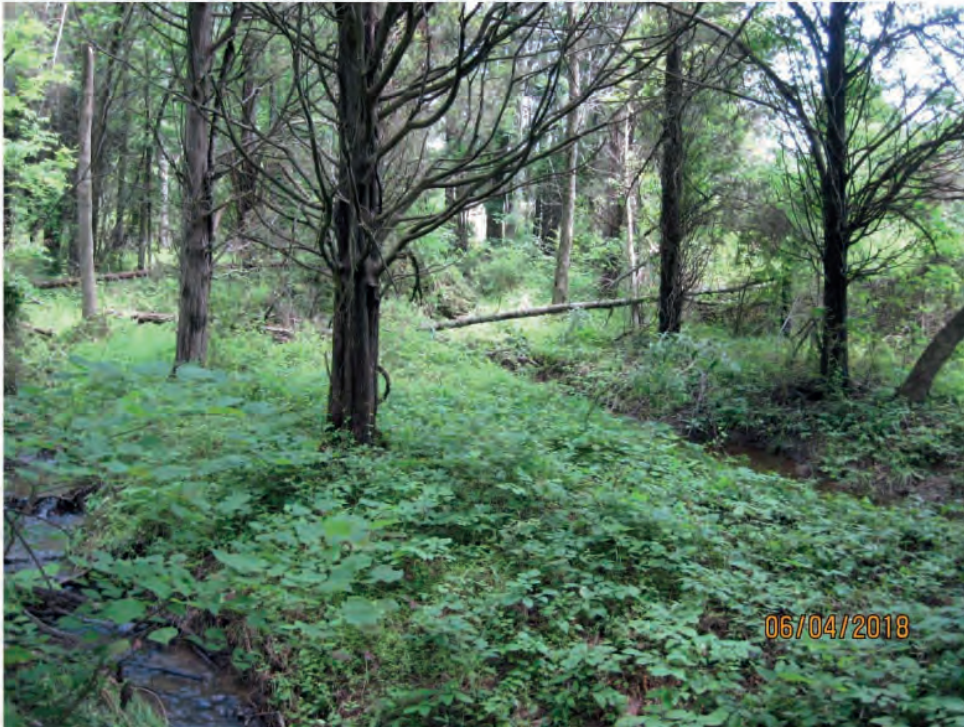
- 31. Looking northeast at the hardwood forest present in the eastern portion of the study area. The area is very wet and has dense herbaceous ground cover, making it “low-quality” small whorled pogonia habitat.**

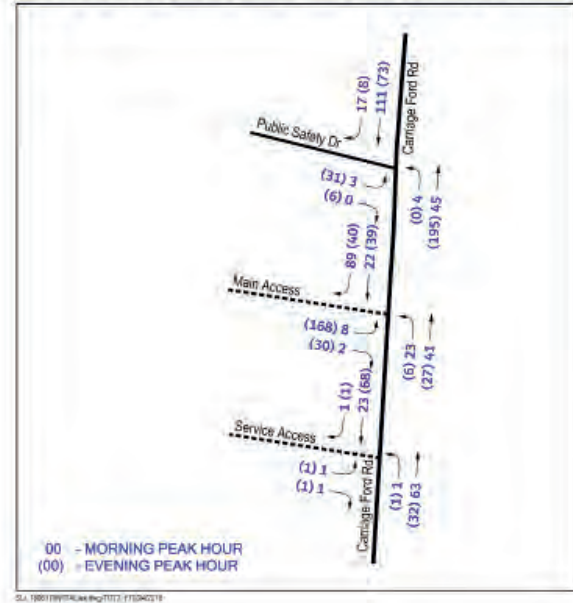
FIGURE 15. 2039 FUTURE PEAK HOUR TRAFFIC VOLUMES (Option #2)
